# Testing and Analysis of the Performance of Pressure Relief Valves – New Test Protocol

## Volume I – Final Report

Battelle Project 100001707  
PERC Docket 17071

December 2011

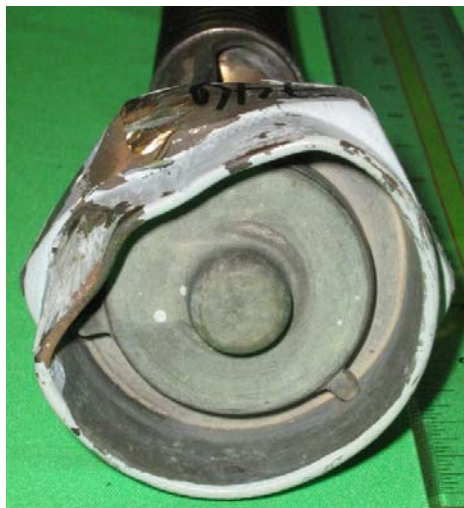
Results for 199 PRVs are presented in the previous figures. PRV #746 was found to have significant physical damage. The PRV leaked significantly and continuously when installed on the conditioning rig such that a conditioning pressure could not be maintained for any length of time. Since the damage was likely due to handling after field service, the PRV was not included in the STD test results. PRV #746 is shown in Figure 39.

**Figure 39. Top View of PRV 746 Showing Significant Physical Damage**

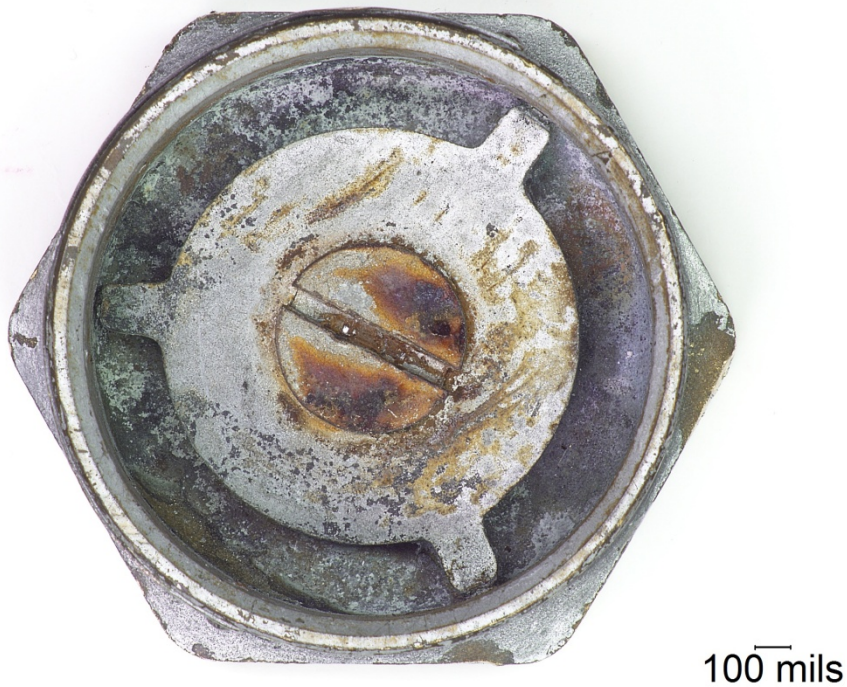
When the PRVs were disassembled, the gasket in PRV 559 was stuck (bonded with adhesive) to the PRV housing. This PRV leaked continuously during testing but eventually discharged at 246.5 psig. The stem and holder in this PRV were different from any of the other PRVs that were examined. The stem was a long bolt that passed through the gasket holder and a small ring gasket was used to form the seal between the head of the stem and the gasket holder. Thus, the leaking and discharge of this PRV occurred at that small gasket rather than at the normal gasket/PRV body seal surface. The configuration of that PRV stem, gasket holder, and small gasket are shown in Figure 47 and Figure 48.

**Figure 47. Slotted head on the Stem from PRV 559**

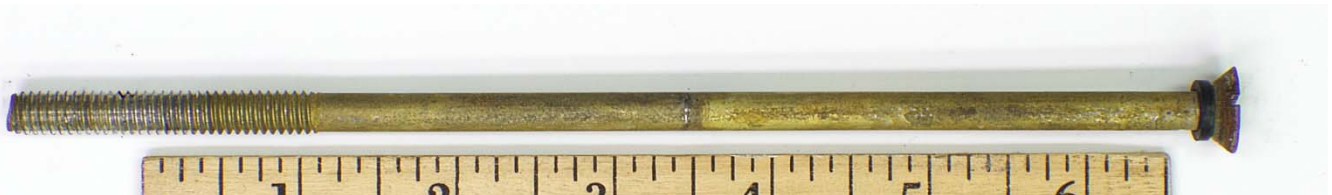
**Figure 48. Small Gasket on the Stem from PRV 559**

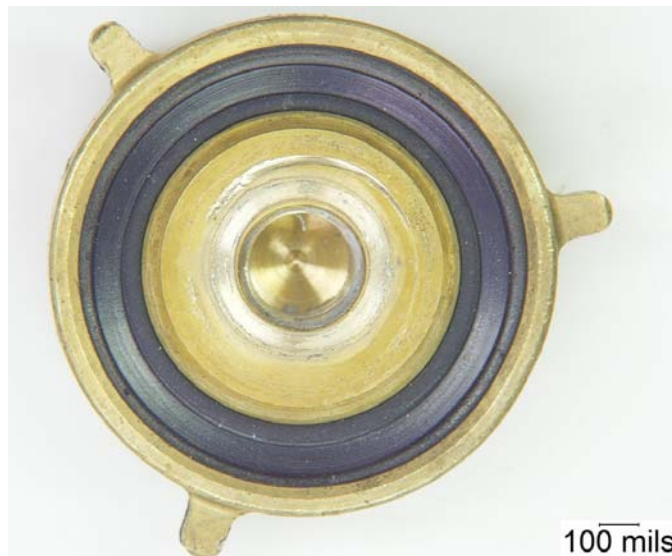
**Figure 52. Nonconcentric Compression Set Rings in the Gasket from PRV 116.**

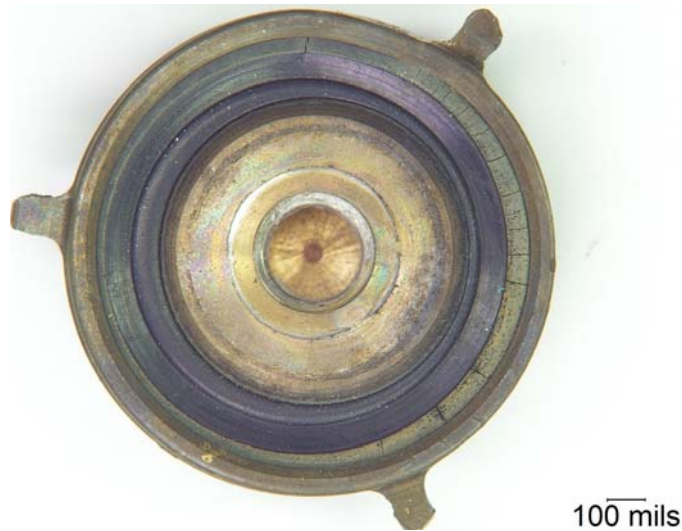
**Figure 53. Nonconcentric Compression Set Rings and Multiple Radial Cracks in the Outer Circumferential Ring of the Gasket from PRV 174.**

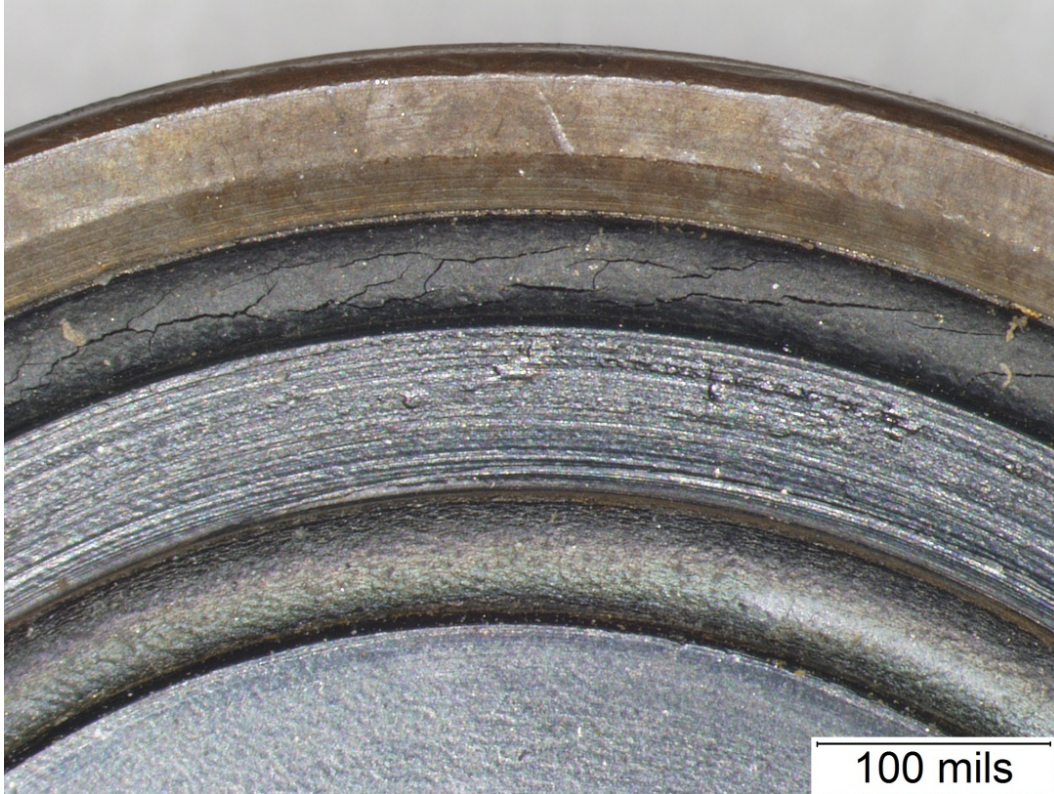
**Figure 54. Multiple Circumferential Cracks in the Outer Circumferential Ring of the Gasket from PRV 511.**

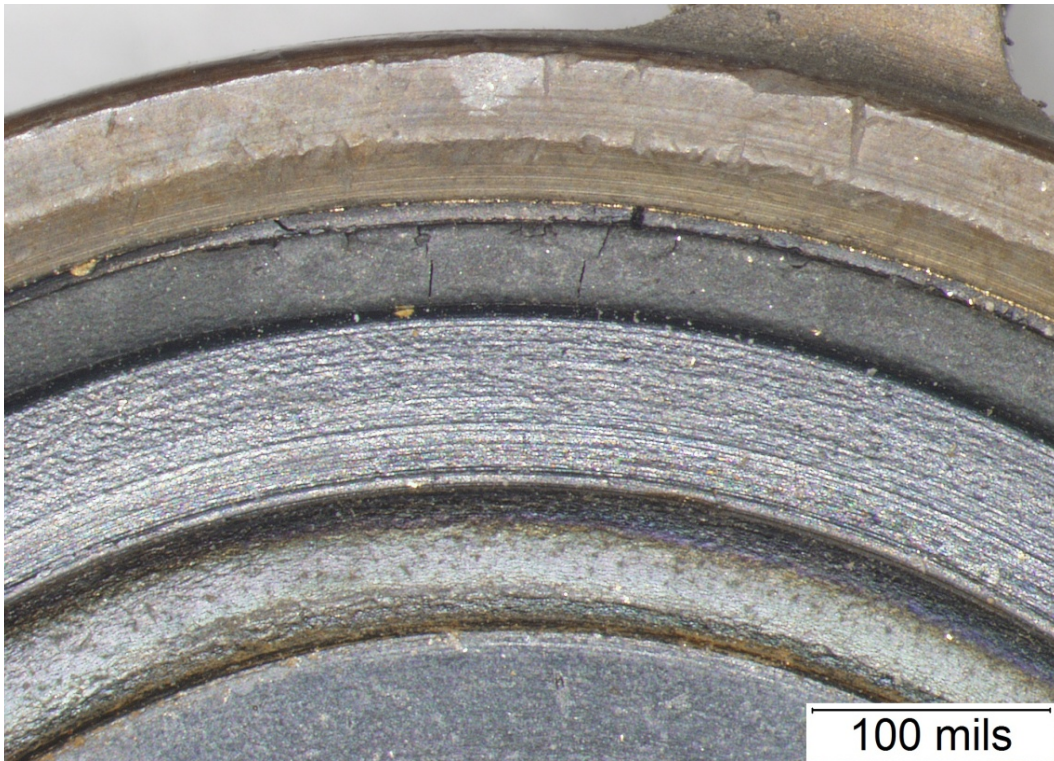
**Figure 55. Radial Cracks in the Outer Circumferential Ring of the Gasket from PRV 511.**

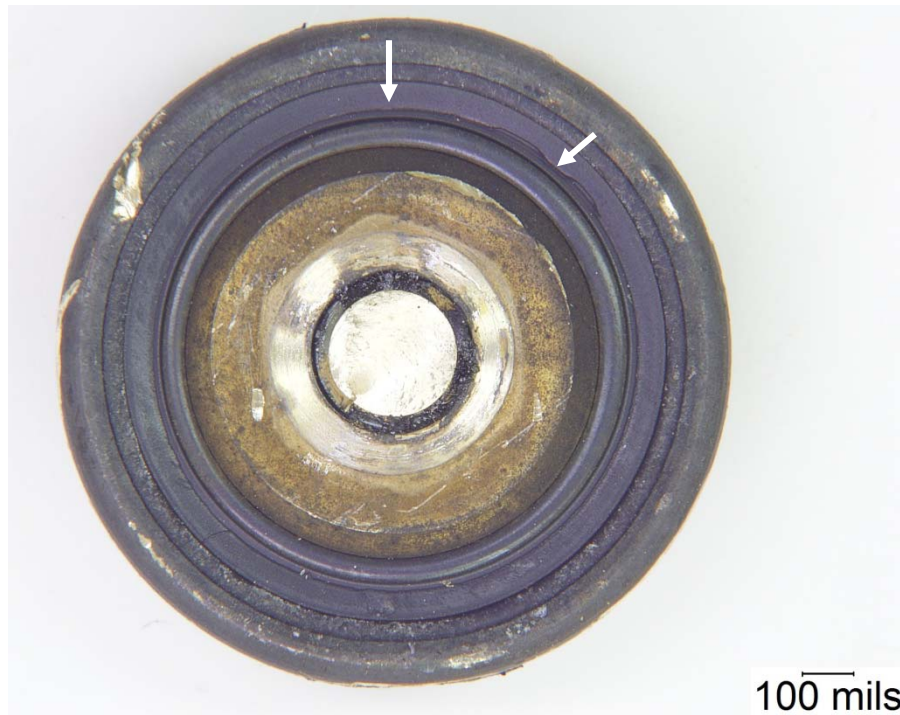
**Figure 56. Material Pull (Arrows) Out from the Seal Surface Region on the Gasket from PRV 696.**

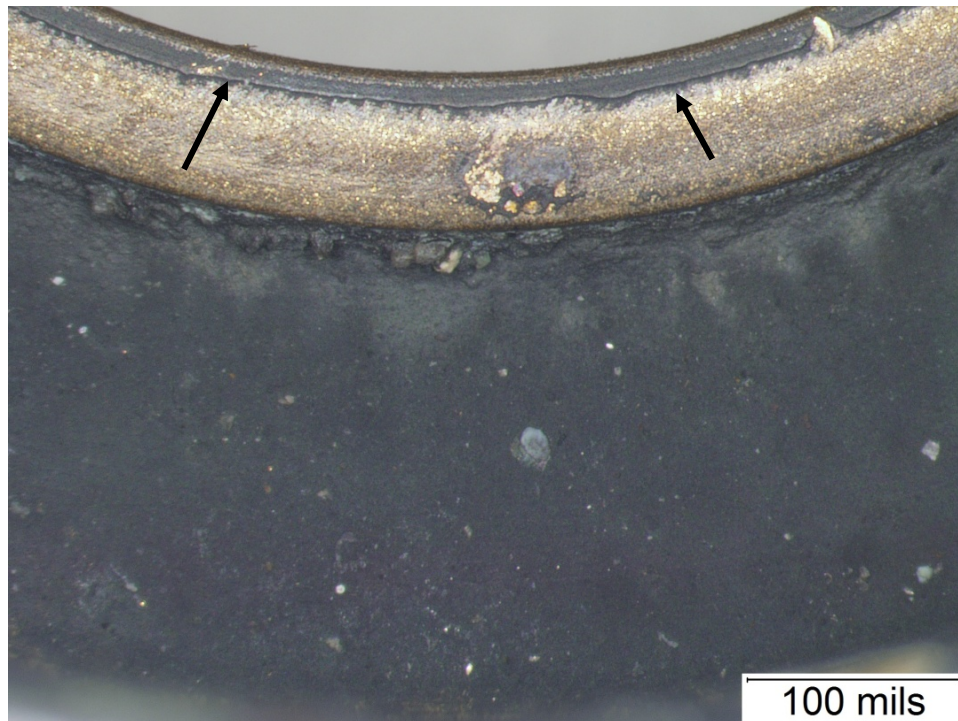
**Figure 58. Material Transfer from the Gasket to the Machined Brass Seal Ring Surface (arrows) in the Housing from PRV 696.**

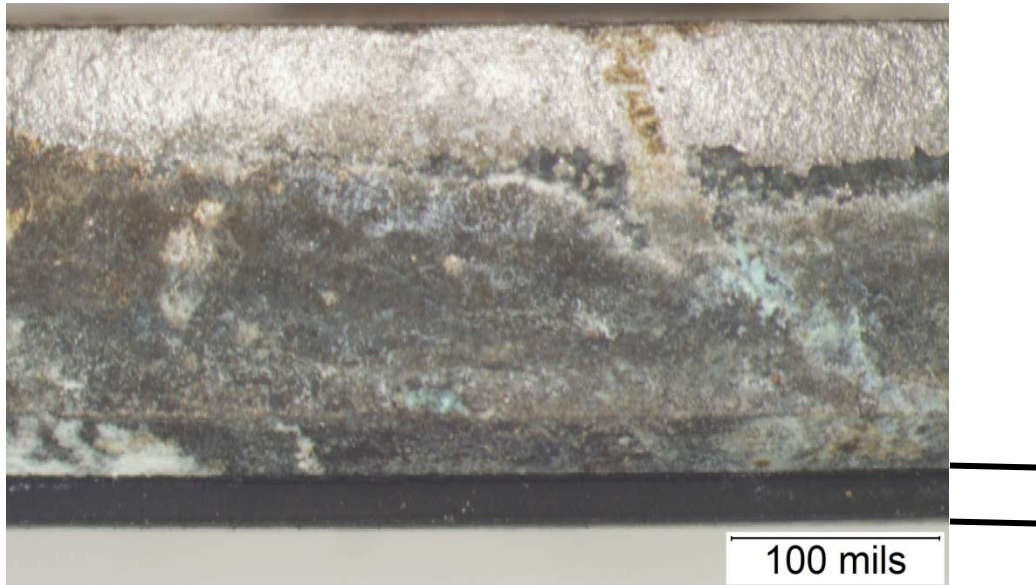
**Figure 59. Thin Gasket on the Surface of the Gasket Holder from PRV 559.**  
*The gasket was about 0.025-inch thick. The black lines indicate the thickness of the gasket.*

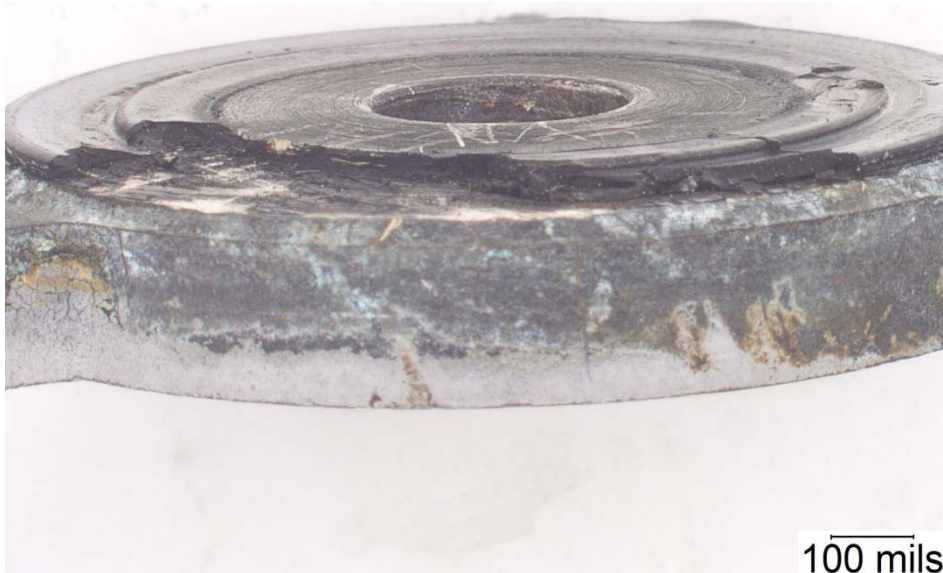
**Figure 60. Gasket on the Surface of the Holder from PRV 559.**  
*A portion of the gasket had been cut away with a razor blade.*

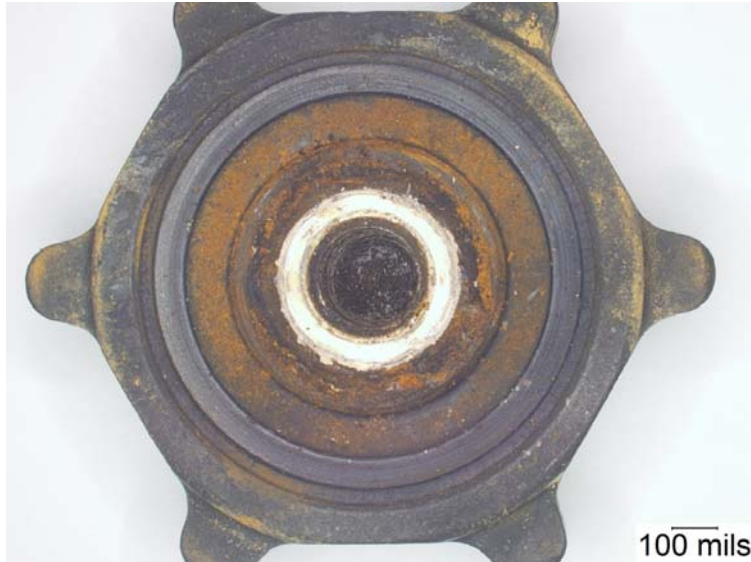
The internal components of PRV 187 were extremely rusty. Most of the rust on the surface of the PRV stem, the spring, the spacer inside the spring, the housing, and the gasket holder appeared to have been deposited on those surfaces rather than formed by corrosion of the surfaces. It was as if this PRV was exposed to rusty water after removal from the tank. There did not appear to be a continuous path of rust across the sealing surface of the gasket. Consequently, there is no conclusive evidence to indicate why this PRV leaked around the gasket during testing.

**Figure 61. Rust on the Surface of the Gasket and the Washer from PRV 187.**  
*The rust was on the portion of the surface that was exposed to propane.*

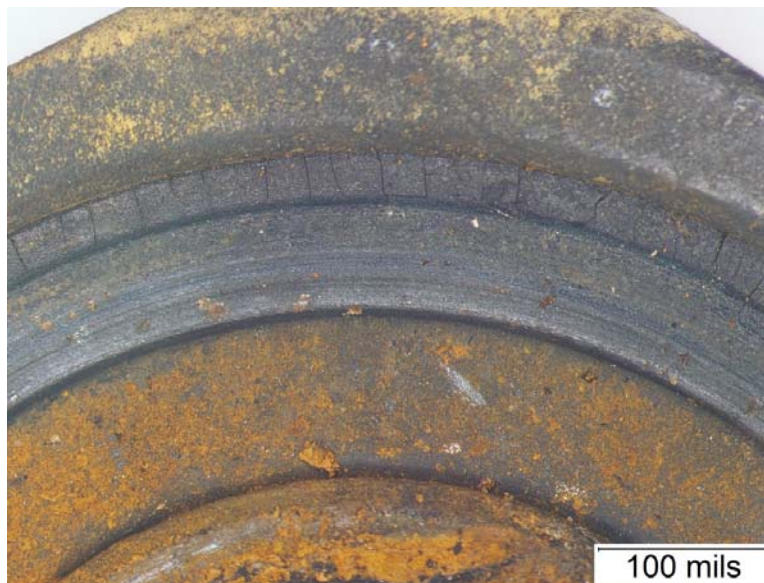
**Figure 62. Higher Magnification View Showing Rust Particles on the Seal Portion of the Surface of the Gasket from PRV 187.**  
*Note also the radial cracks in the outer ring of the gasket.*

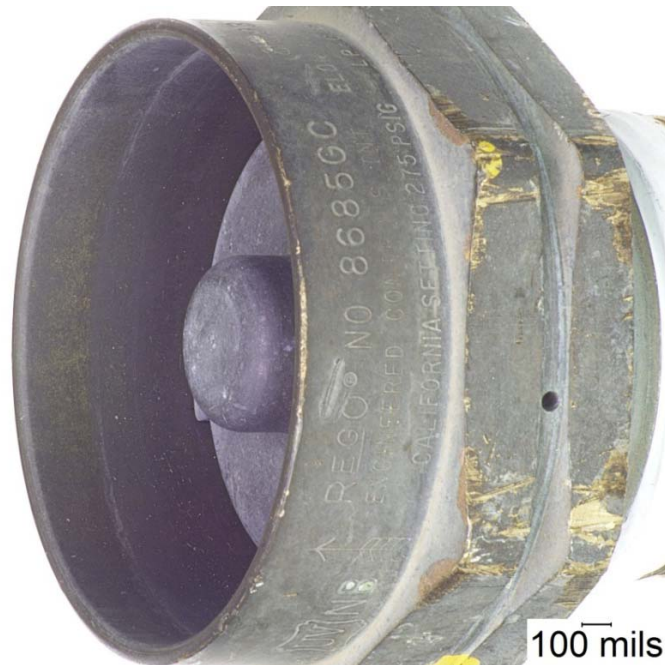
**Figure 69. Faint Internal Rain-Cap Line on the Housing from PRV 140.**

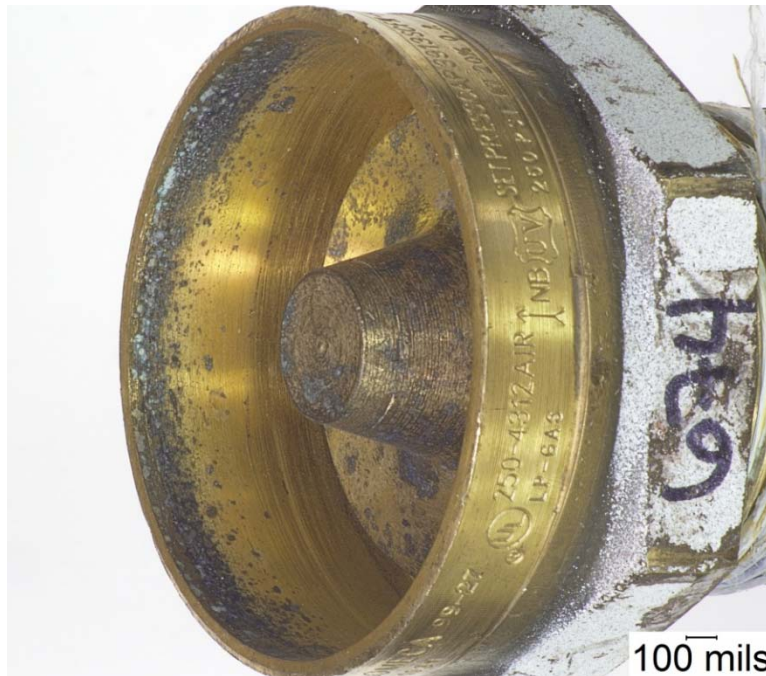
**Figure 70. Distinct External Rain-Cap Line on the Surface of the Housing from PRV 674.**

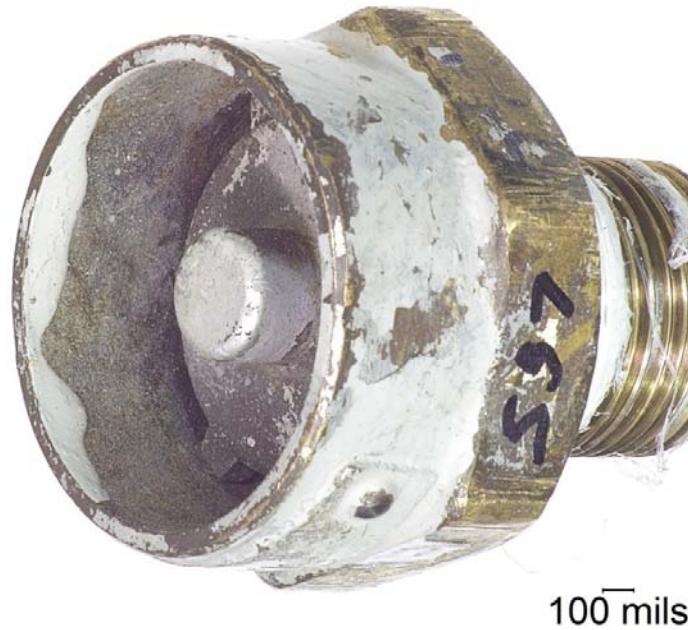
PRV 597 appeared to be in relatively good condition; however, there was a dent in the machined surface of the housing that also imprinted on the gasket. These features were the only deficiencies observed and they do not appear to be the reason for the low STD pressure behavior. Based upon this examination there is no conclusive evidence for the low STD pressure behavior.

**Figure 71. Housing from PRV 597 Showing no Evidence of Internal or External Rain-Cap Lines.**

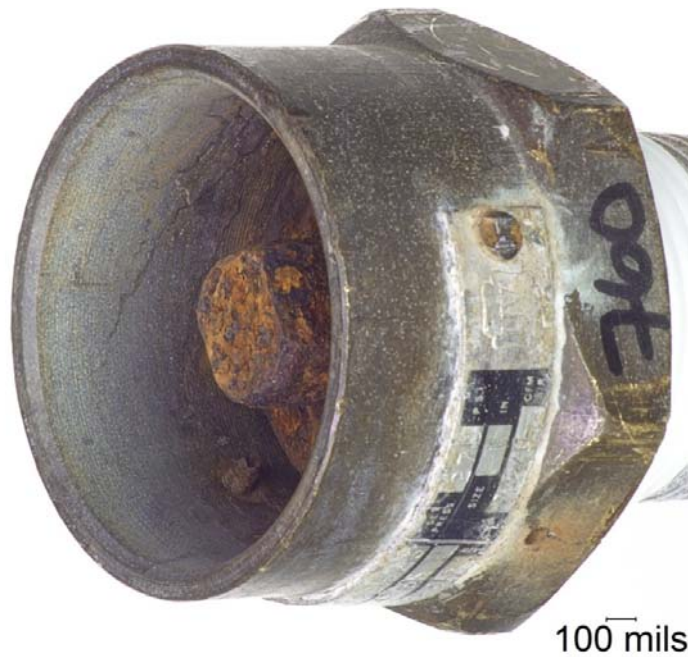
**Figure 72. Housing from PRV 760 Showing no Evidence of Internal or External Rain-Cap Lines.**

*Note the severe corrosion on the surface of the gasket holder.*

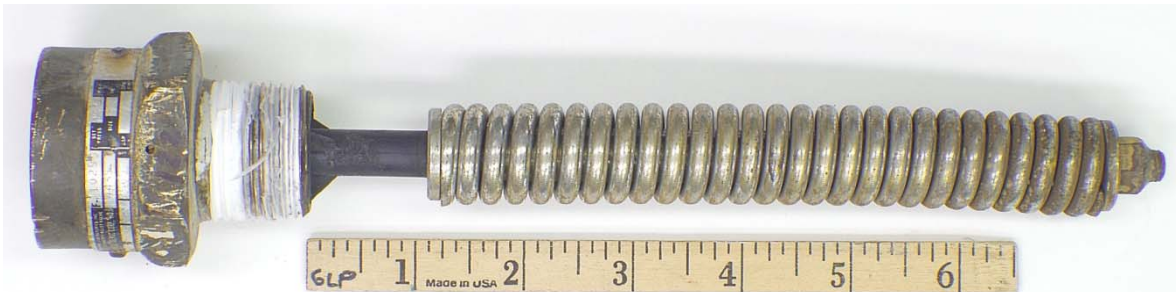
**PRVs that Did Not Open:** Only 2 out of 200 PRVs tested (1 percent of the test population) did not open after reaching 375 psig. Both of these PRVs (PRV 122 and PRV 760) had 275-psi set pressures and the fact that they did not open was not found to be statistically significant (could have occurred by chance). Both PRVs were produced by Manufacturer C and are identical models. PRV 122 was 34 years old and PRV 760 was 39 years old. Examinations of these two PRVs showed many similar features, including stems that were difficult to remove from the PRV housing and severely corroded gasket holders. Based upon the examinations of PRV 122 and PRV 760, the Battelle investigators believe that the reason for the observed behavior was that the stems had become ‘stuck’ to the guide fittings during service even though significant corrosion did not occur between those surfaces.

**Figure 73. Overall View of PRV 122 (275-psig Set Pressure) that Did Not Open During Pressure Testing. Note the bow in the spring.**

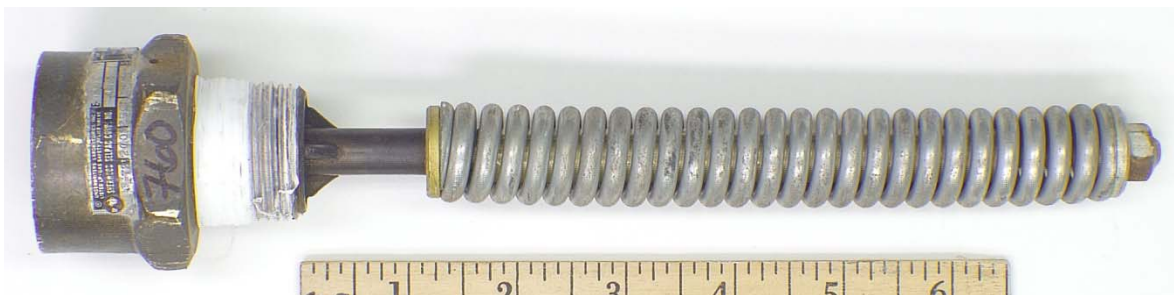
**Figure 74. Overall View of PRV 760 (275-psig Set Pressure) that Did Not Open During Pressure Testing. Note the slight bow in the spring.**

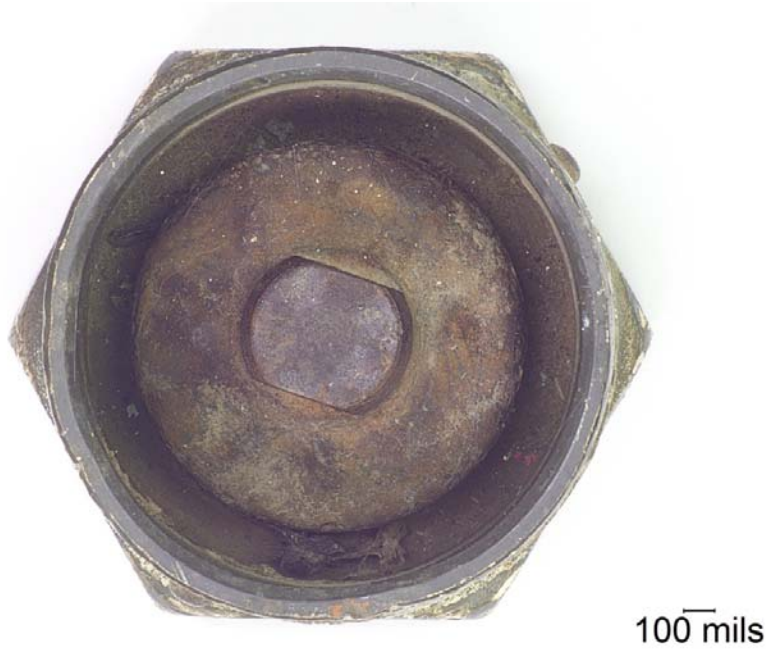
**Figure 75. Discoloration of the Inside Surface of the Housing, Debris Inside the Housing, and Rust on the Surface of the Gasket Holder from PRV 122**

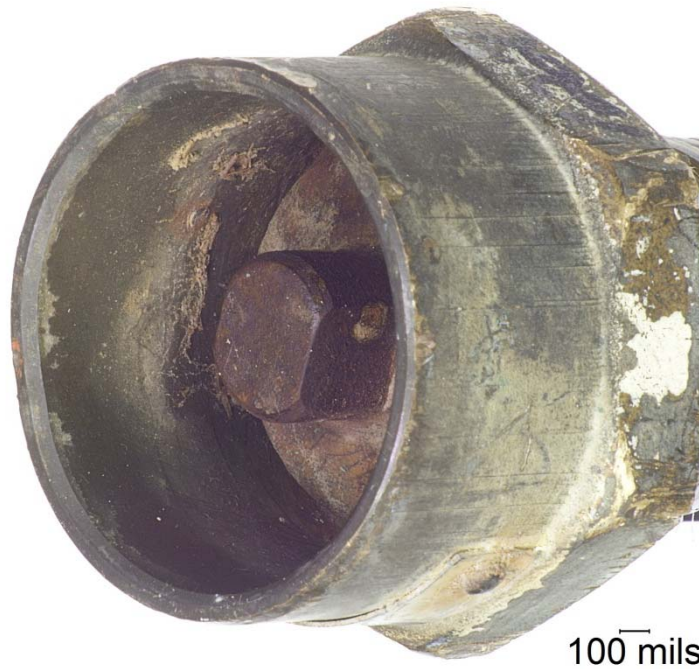
**Figure 76. Additional Debris on the Inside Surface and the Absence of Rain-Cap Lines on the Internal and External Surfaces of the Housing from PRV 122.**

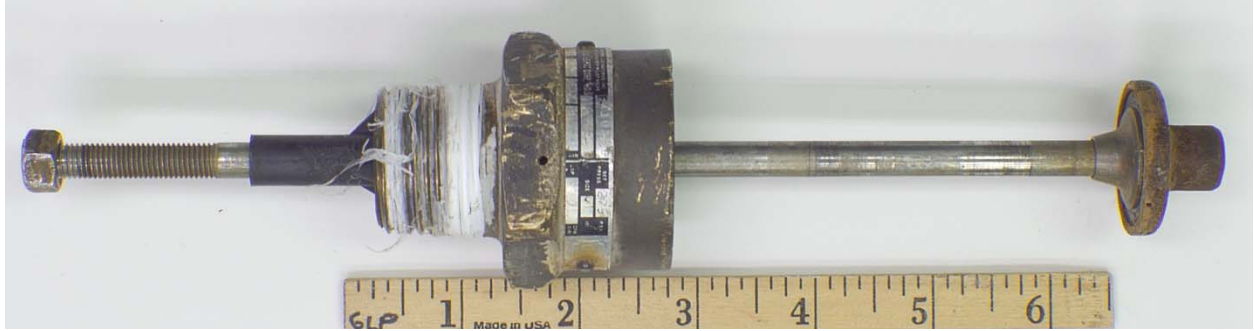
**Figure 78. Stem Partially Pushed Out of the Housing from PRV 122.**  
*The shiny marks on the stem were caused when it turned during disassembly.*

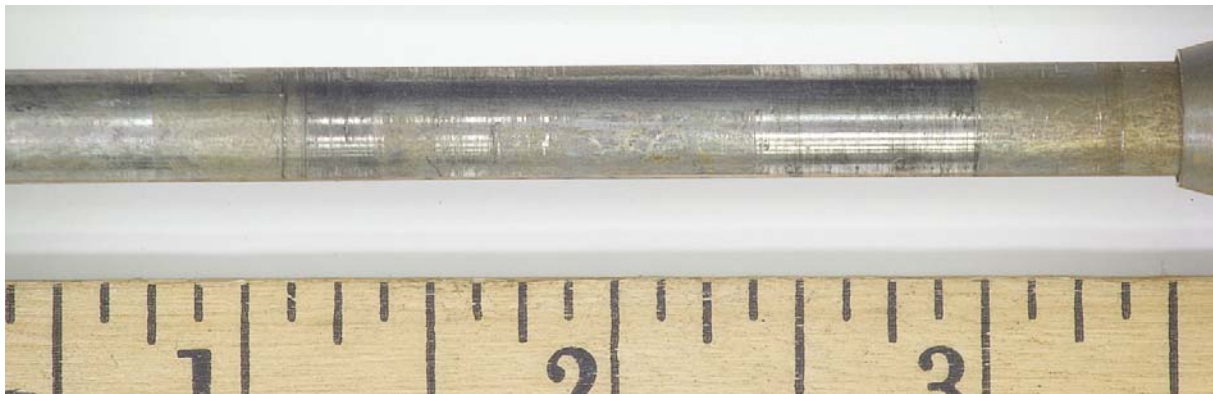
**Figure 79. Circumferential Rub Marks on the Surface of the Stem from PRV 122.**  
*The rub marks were caused when the stem turned during disassembly.*

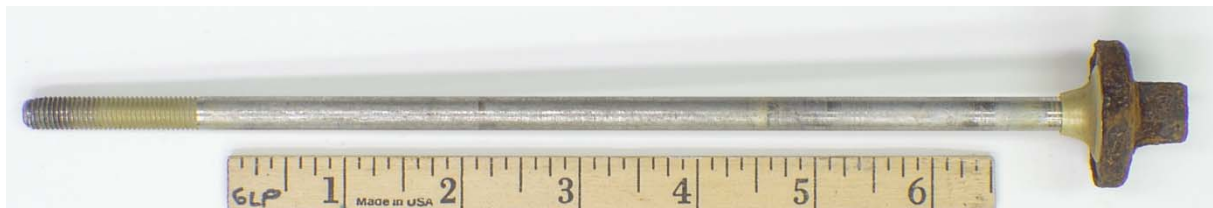
**Figure 80. Appearance of the Stem After it was Pushed Out of the Housing from PRV 760.**

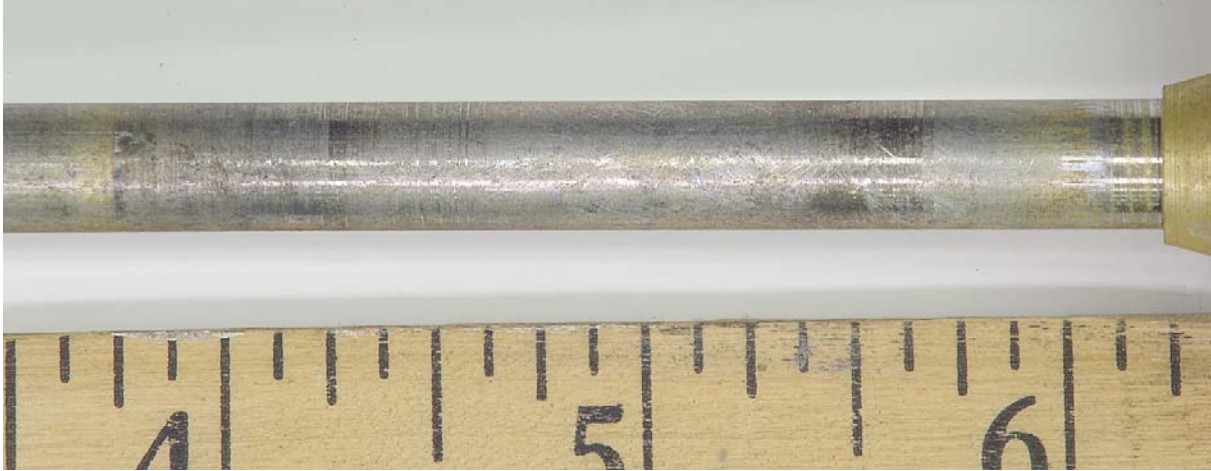
**Figure 81. Circumferential Rub Marks on the Surface of the Stem from PRV 760.**  
*The rub marks were caused when the stem turned during disassembly.*

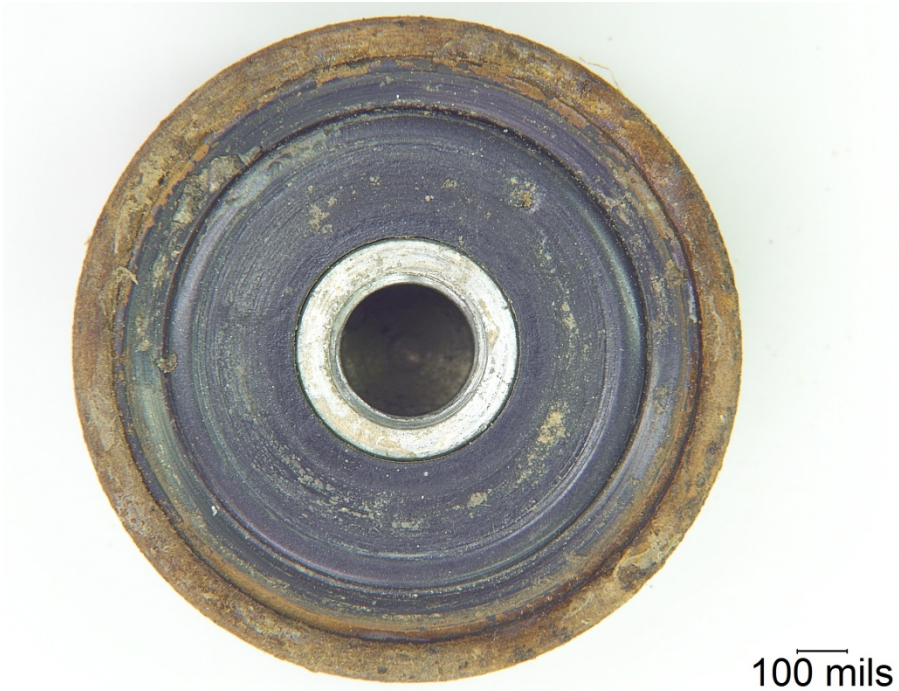
**Figure 82. Rusted Bottom Surface of the Gasket Holder and Debris on Seal Surface Region of the Gasket from PRV 122.**

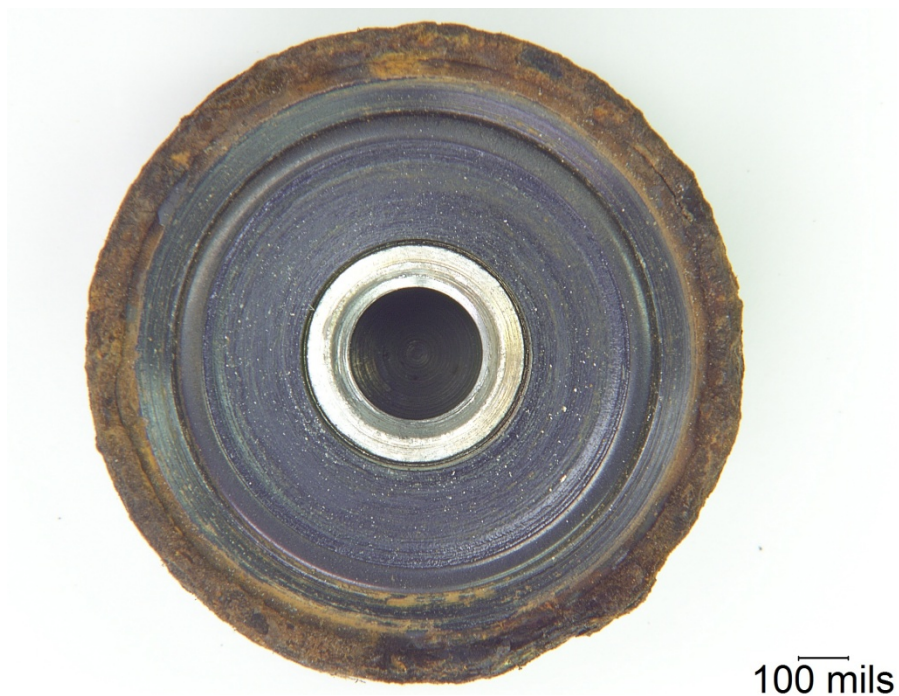
**Figure 83. Severely Corroded Bottom Surface on the Gasket Holder from PRV 760.**

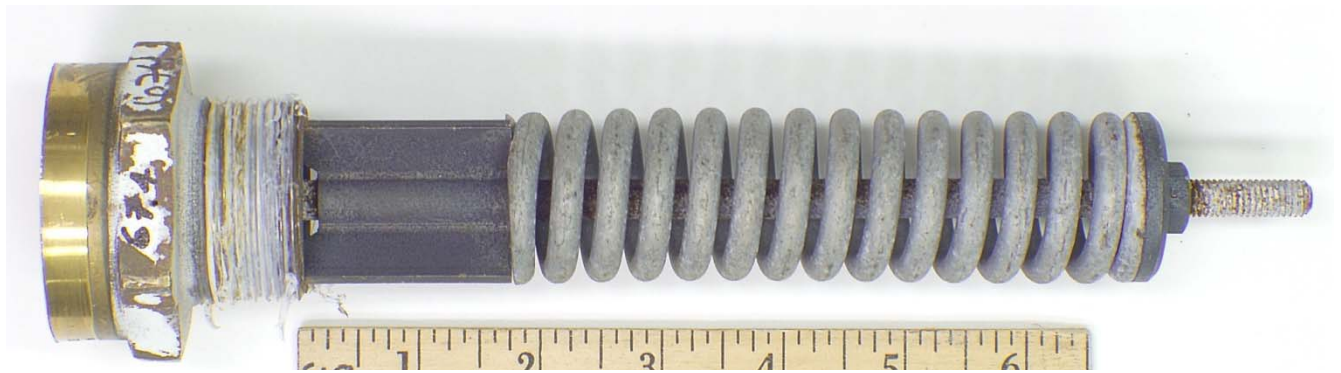
Examination of those PRVs revealed that most of them showed relatively little evidence of deterioration as a result of their service lives. The one high STD PRV that exhibited the most extensive corrosion on its exposed components was PRV 674 which had been in service for 53 years. This PRV was tested twice to 350 psig without opening; on the third pressurization cycle the PRV opened at 254 psig, very near the set pressure for the PRV. When the PRV was disassembled, the stem was stuck in the spacer guide and PRV housing. The stem was pushed out of the housing and spacer guide using an Instron universal testing machine. The load required to get measurable movement of the stem was 968.2 pounds (displacement was 0.015 inches). The load then dropped to between 500 and 600 pounds to move the stem. Based upon those measurements, it is difficult to understand how the PRV discharged at 254 psig during the third pressurization cycle. The Battelle investigators concluded that the high STD behavior of PRV 674 was caused by the corrosion of the stem and spacer fitting that was exposed to the environment inside the propane tank. This type of corrosion indicates that there was a significant amount of moisture inside the tank.

**Figure 84. Overall View of PRV 674, 250-psig Set Pressure PRV that Exhibited High STD Behavior.**

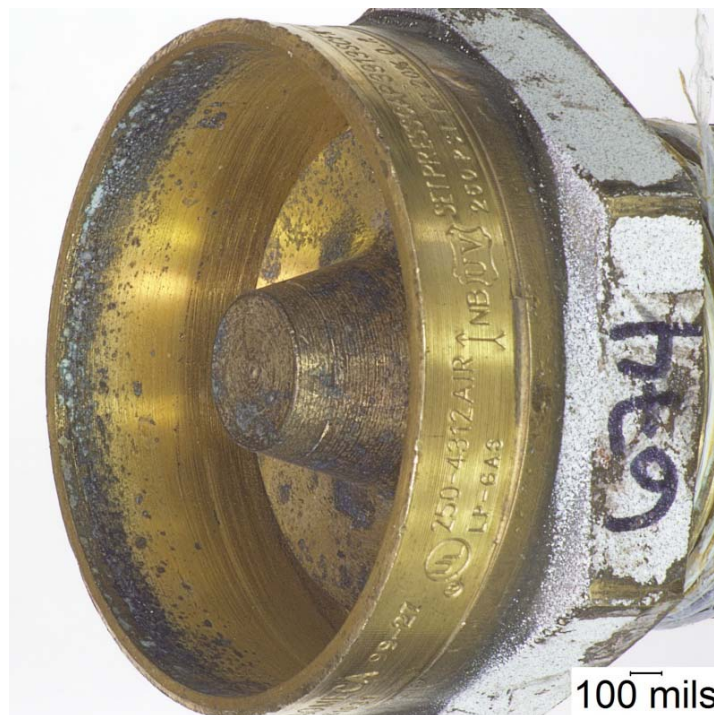
**Figure 86. Lack of Discoloration and Corrosion on the External Surface of the Housing but a Band of Corrosion Near the Top of the Internal Surface from PRV 674.**

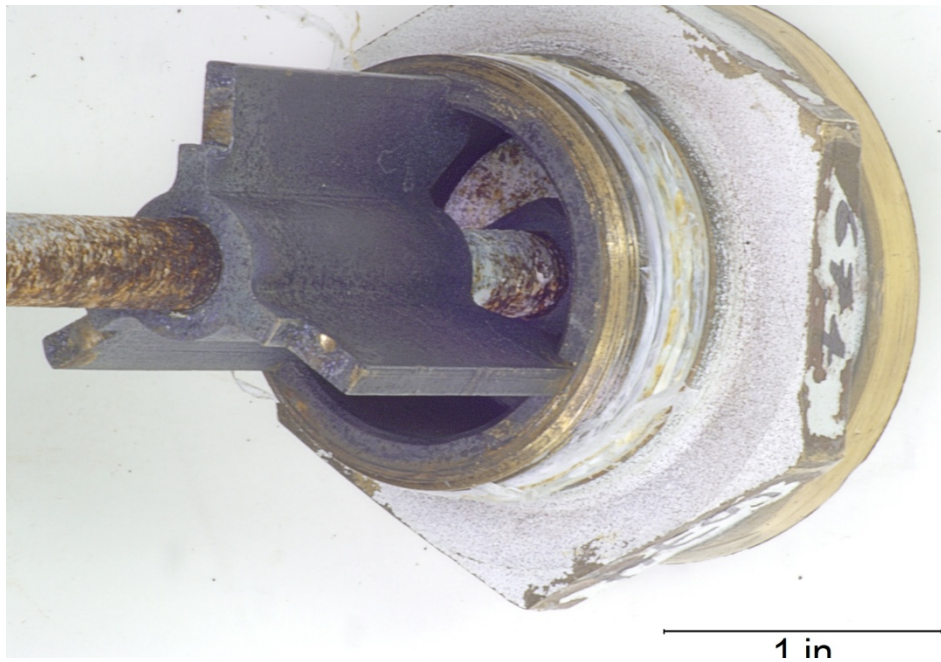
**Figure 87. Corrosion Products (Red Rust and "White" Rust on the Surface of the Stem and Black Corrosion Products on the Surface of the Spacer Guide) from PRV 674.**

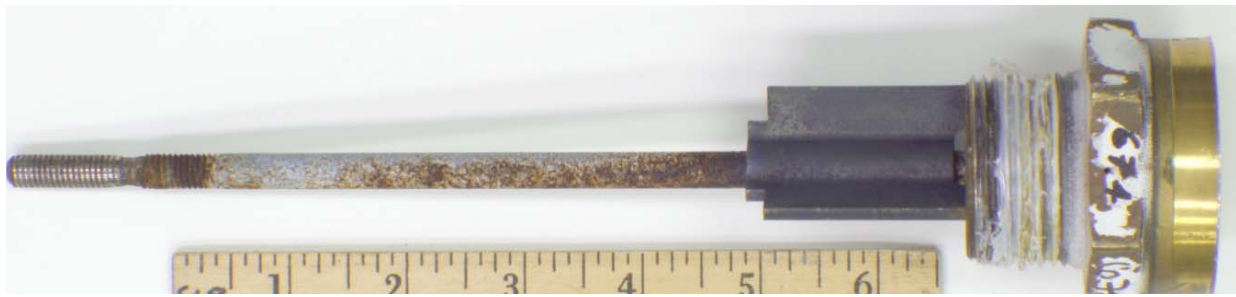
**Figure 88. Mixed-Color Corrosion Products on the Surface of the Stem from PRV 674.**

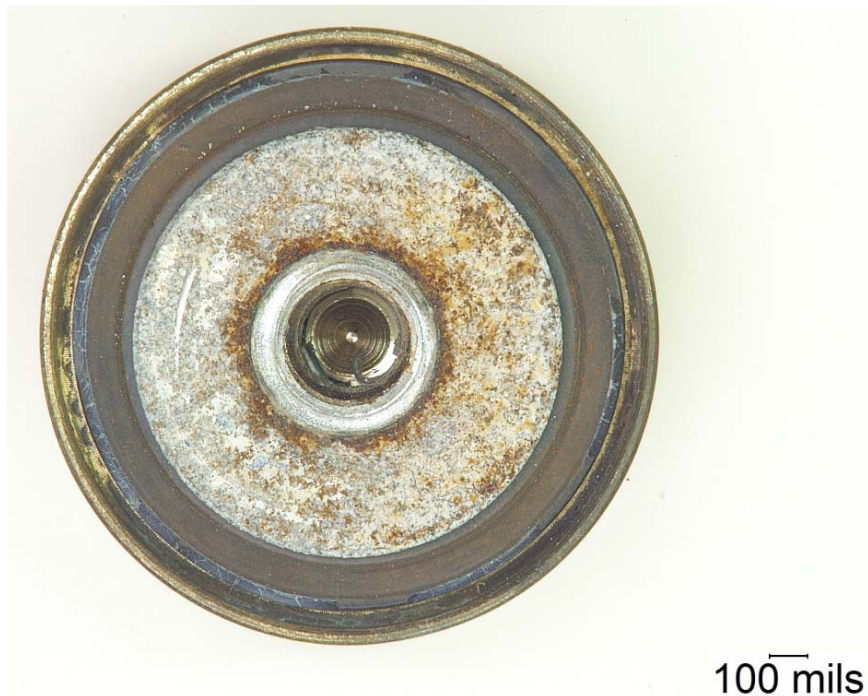
**Figure 89. Mixed-Color Corrosion Products on the Surface of the Gasket Washer from PRV 674.**

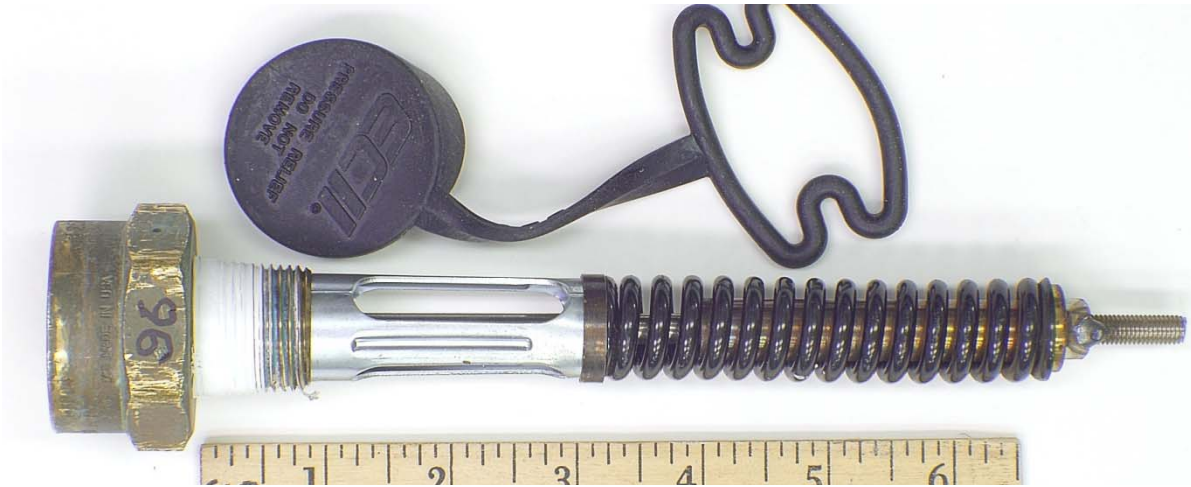
**Figure 90. PRV 96, 250-psig Set Pressure, that Exhibited High STD Behavior.**  
*This PRV was four years old.*

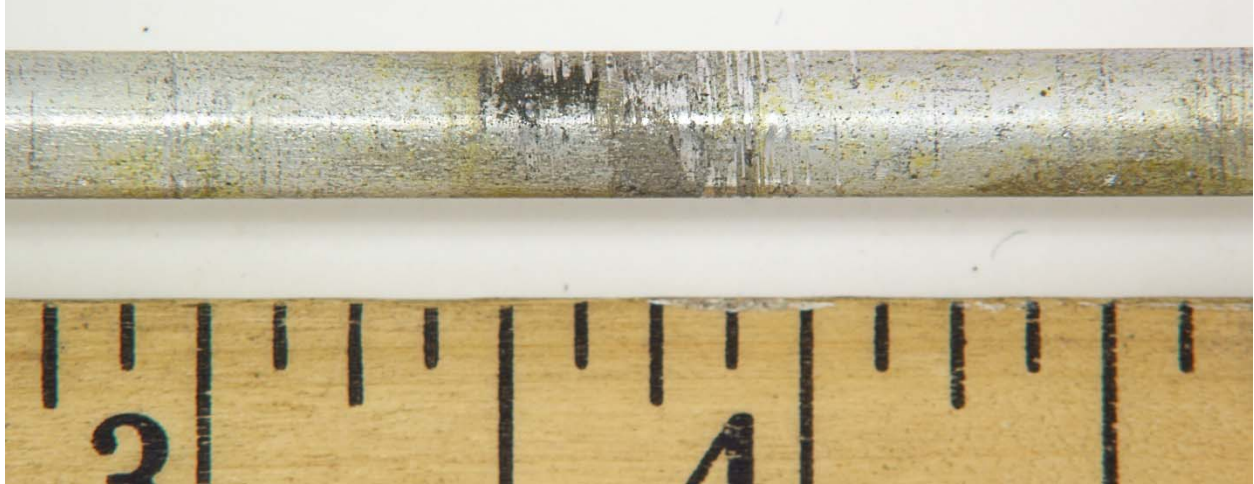
None of the other PRVs that exhibited high STD behavior during testing exhibited the extent of corrosion to their components as did PRV 674. However, all of them did exhibit a distinct mark on the PRV stem formed by contact between the PRV stem and the spacer guides. In addition, none of the PRVs exhibited evidence of sticking of the gaskets when they were disassembled. Consequently, the Battelle investigators concluded that the most likely reason for their high STD behavior was the sticking of the PRV stem to the guide spacers or guide washers.

**Figure 107. Mark on the Surface Formed by Contact Between the PRV Stem and the Spacer Guide from PRV 523.**

does not occur. This behavior suggests that the use of solid film lubricants or CPCs (corrosion prevention compounds) might be highly beneficial to improve PRV performance.

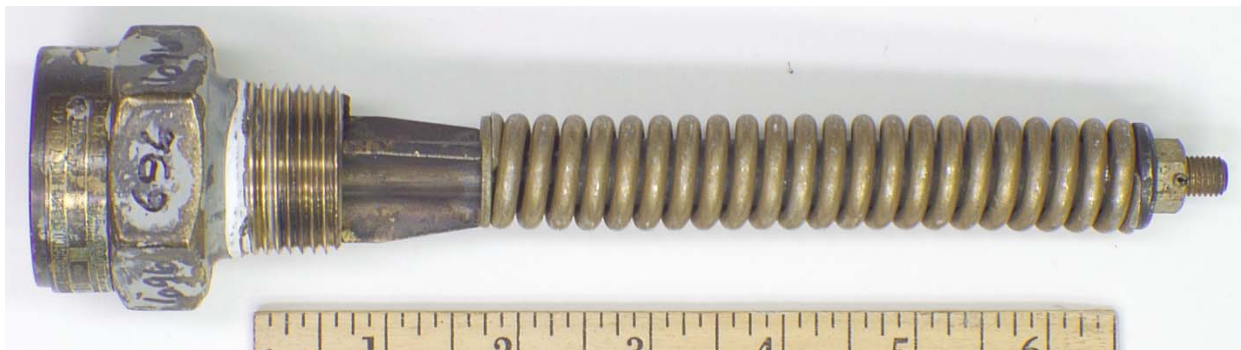
**Figure 108. PRV 696, 250-psig Set Pressure PRV that Exhibited High STD Behavior. *This PRV was 57 years old.***

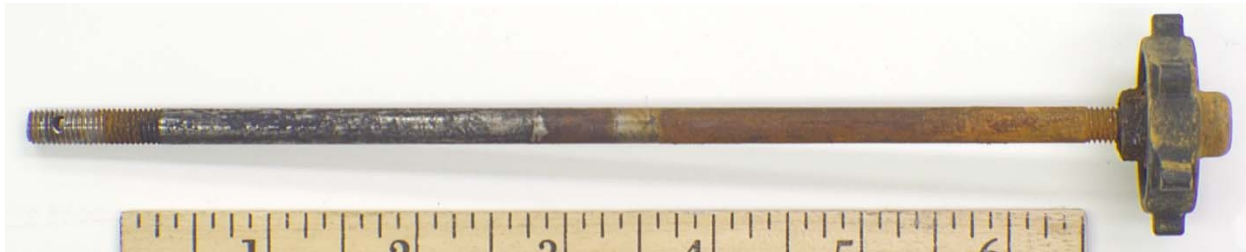
**Figure 112. PRV Stem from PRV 187.**

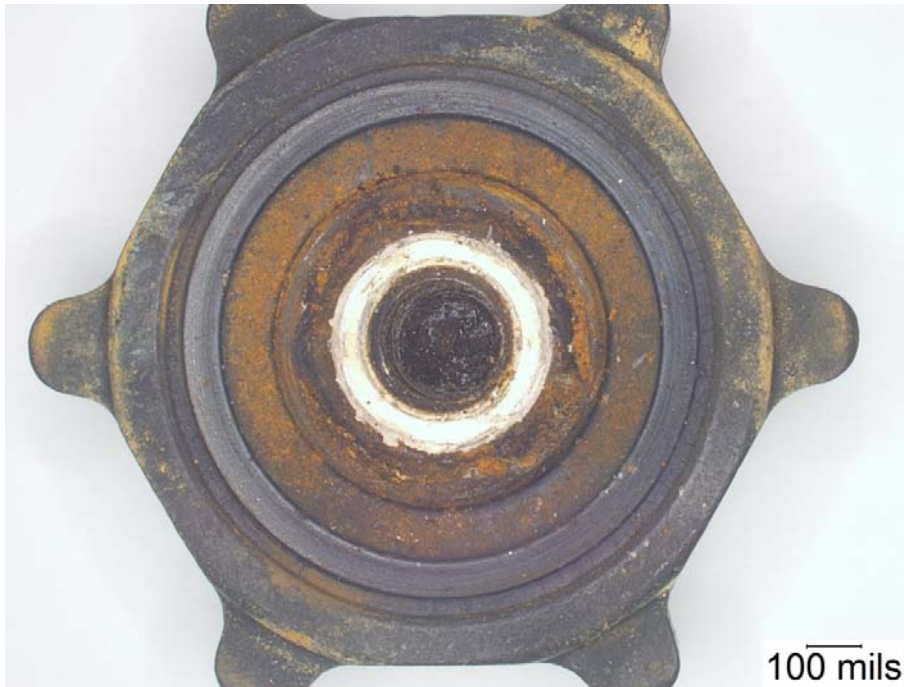
**Figure 113. Rust Deposits on the Surface Region of the Gasket that was Exposed to a Propane Environment During Service.**

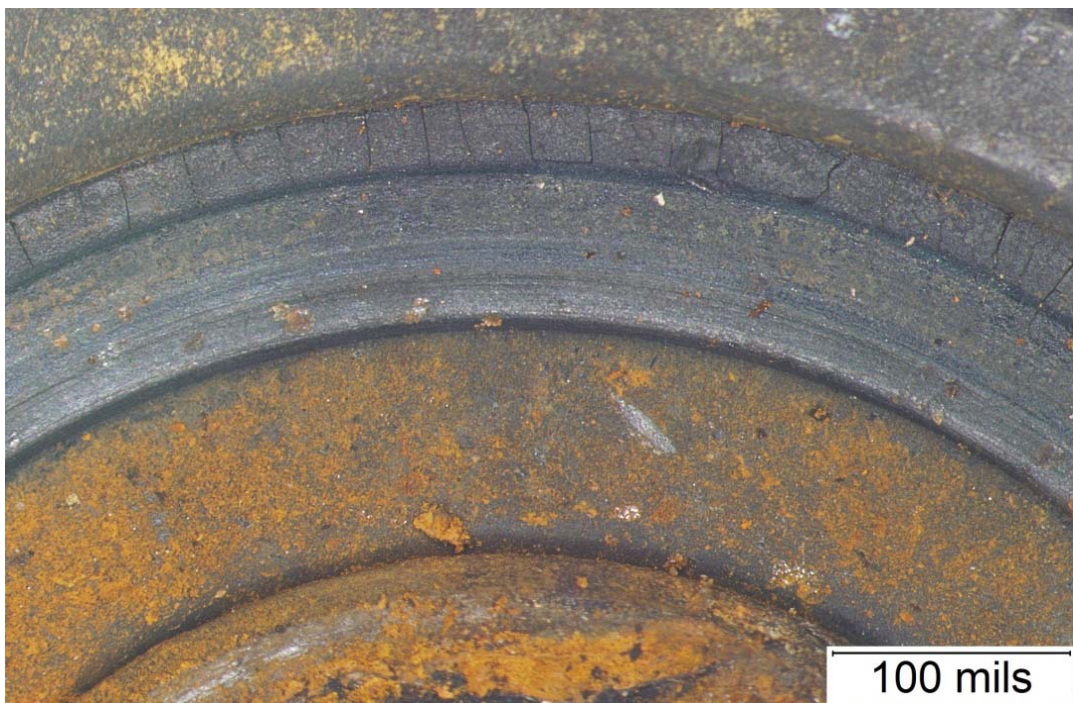
**Figure 114. Rust Deposits on the Surface of the Gasket and the Gasket Washer that were Exposed to a Propane Environment During Service and Rust Particles on the Seal Region Surface.**

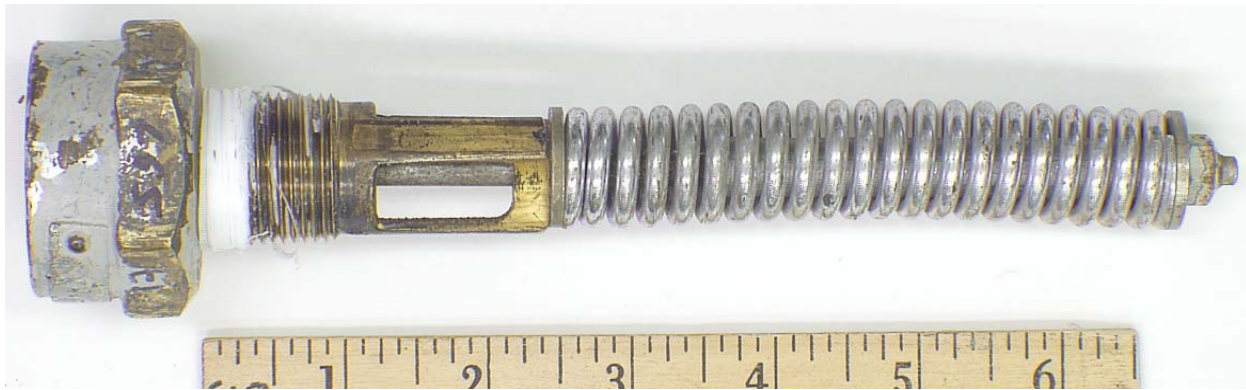
**Figure 115. PRV 597, 275-psig Set Pressure PRV that Exhibited Low STD Behavior.**  
*This PRV was 40 years old.*

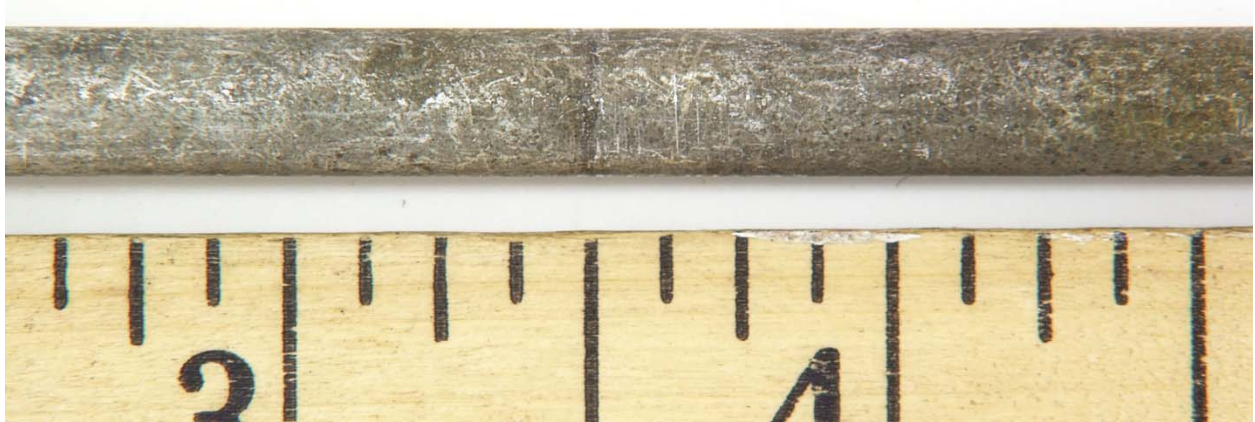
**Figure 121. Higher Magnification View of the Surface of the PRV Stem from PRV 597.**
