# Testing and Analysis of the Performance of Pressure Relief Valves – New Test Protocol

## Volume I – Final Report

Battelle Project 100001707  
PERC Docket 17071

December 2011

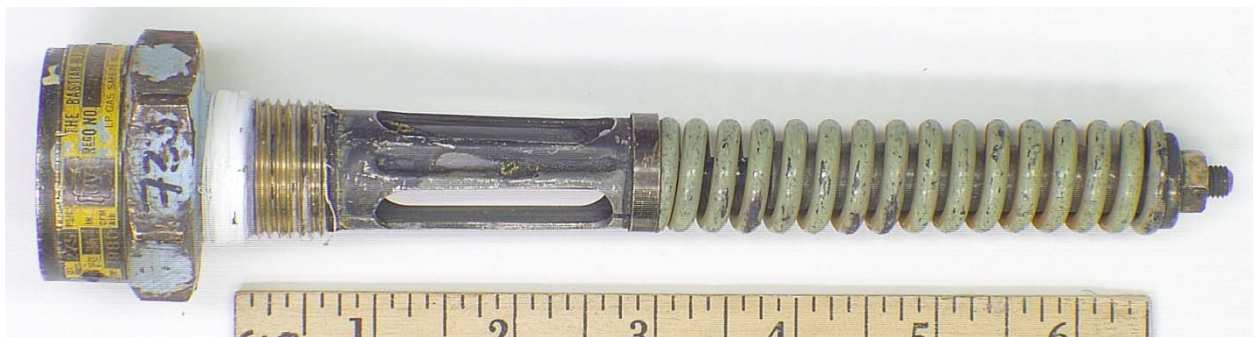
PRV 733 also appeared to be in relatively good condition. The spacer was discolored and some of the coating had chipped off the spring but there was no significant corrosion. PRV 733 did have a crack in the sealing surface of the gasket. It is possible that this crack caused the low STD pressure behavior of this PRV. Also, the average hardness of the gasket was 63 Shore D, the second highest hardness measured on the gaskets.

**Figure 122. PRV 733, 275-psig Set Pressure PRV that Exhibited Low STD Behavior.**  
*This PRV was 50 years old.*

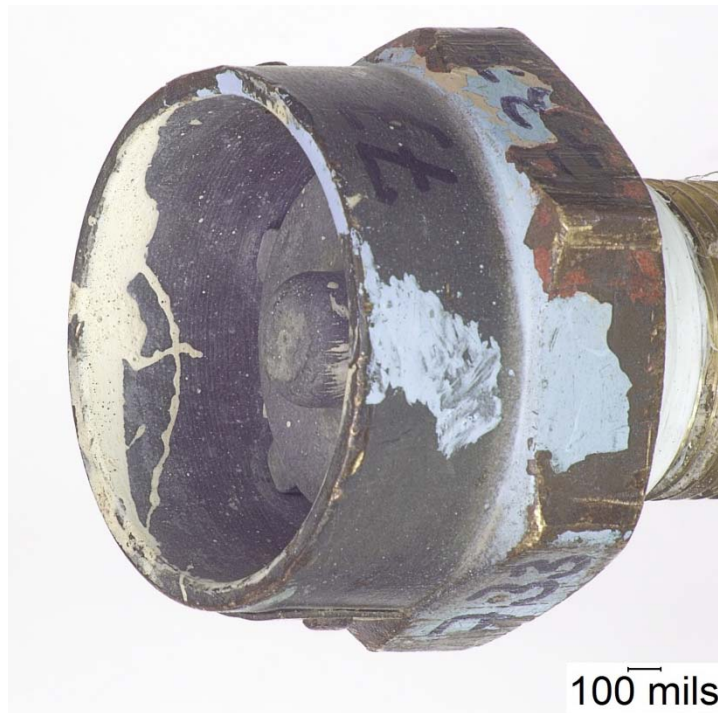
**Figure 123. Discoloration and Paint on the Internal and External Surfaces of the Housing from PRV 733.**

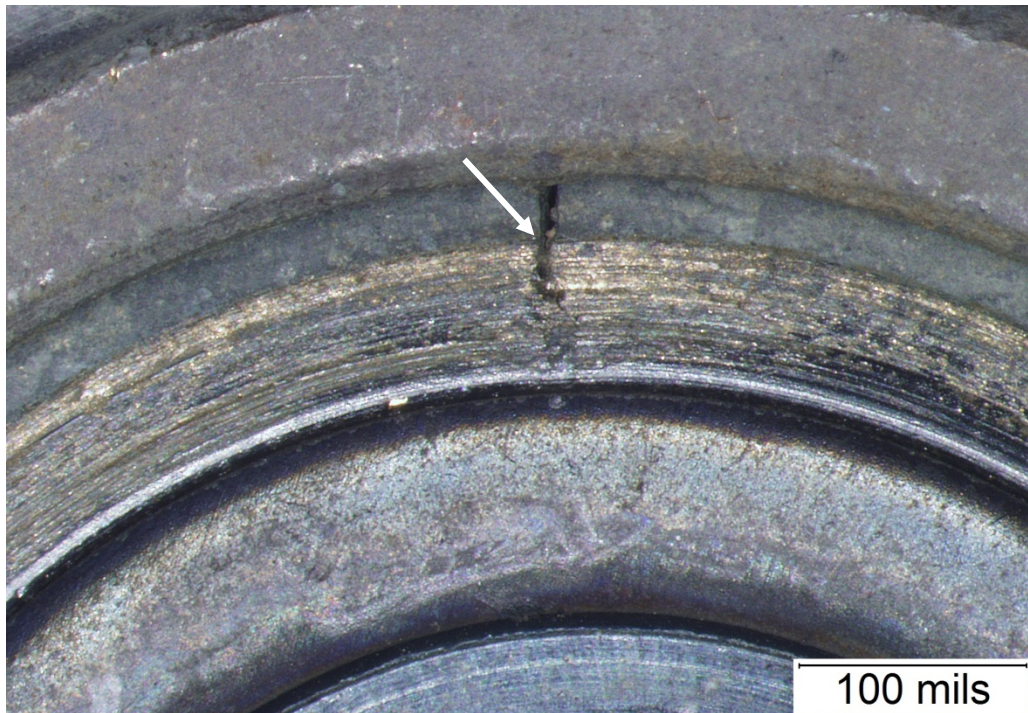
**Figure 124. Crack in the Seal region Surface of the Gasket from PRV 733.**
