# Testing and Analysis of the Performance of Pressure Relief Valves – New Test Protocol

## Volume I – Final Report

Battelle Project 100001707  
PERC Docket 17071

December 2011

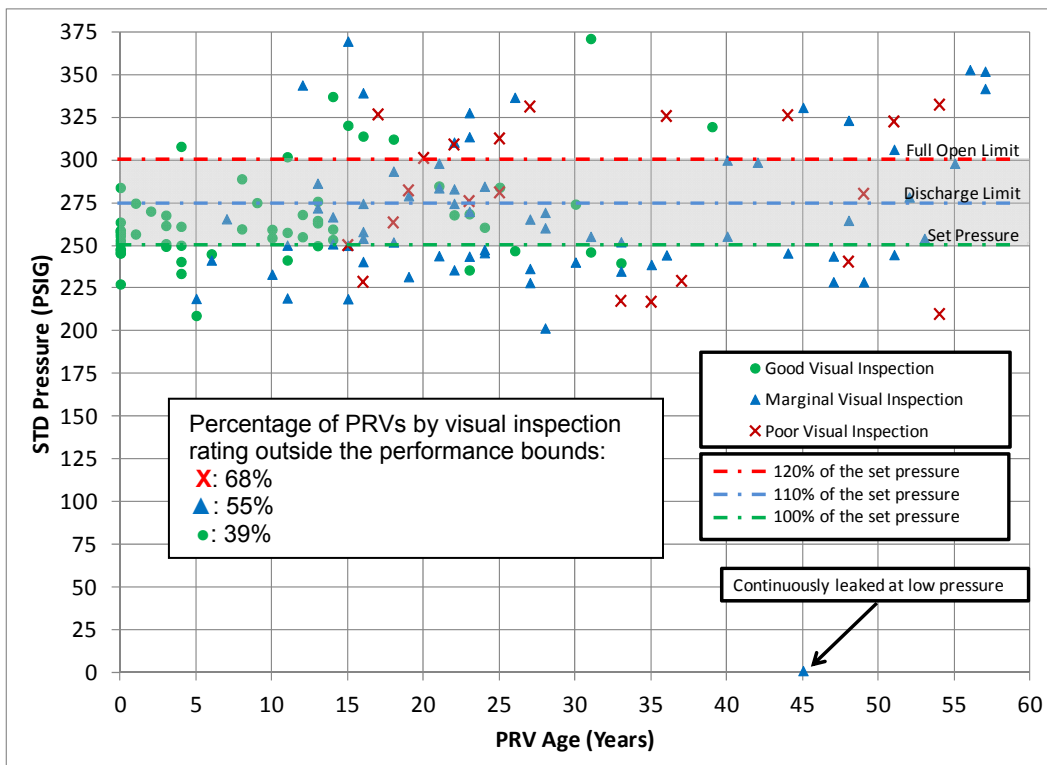
**Figure 1. STD Pressure as a Function of Age, 250-psig Set Pressure PRVs**

Figure 1 and Figure 2 compare the STD pressures to the NPC and age for the 250-psi and 275-psi set pressure PRVs tested in this program. The vertical axis is the parameter tested (pressure) while the horizontal axis is an indication of the age of the PRV tested. The colored horizontal lines represent the set pressure, STD pressure, and full open pressure limits as specified in UL 132. The three different data symbols represent the pre-test visual inspection results (● = good; ▲ = marginal; ✕ = poor). The darker gray band represents the range of acceptable PRV performance against the NPC. Data points with the label ‘DNO’ signify PRVs that did not open by 375 psi (1.5x the working pressure of a propane tank, equivalent to the hydrotest pressure). Significant differences between ages are evident by the variation in the vertical spread of the data points.

The test results show broad scatter in PRV performance against the NPC for PRVs older than 15 years of age for 250-psig set pressure PRVs and 30 years of age for 275-psig set pressure PRVs. The results also show that there are a higher percentage of PRVs older than 15 years receiving a ‘marginal’ or ‘poor’ visual inspection rating. Although high STD pressures begin to appear after 10 years, there does not appear to be a discernible trend of their percentage increasing with age until after 25 to 30 years of age (see Figure 3). The data suggests that PRV performance against the NPC may be influenced by PRV maintenance – PRVs that received ‘marginal’ or ‘poor’ visual inspection ratings tend to have STD pressures outside the bounds of the NPC.

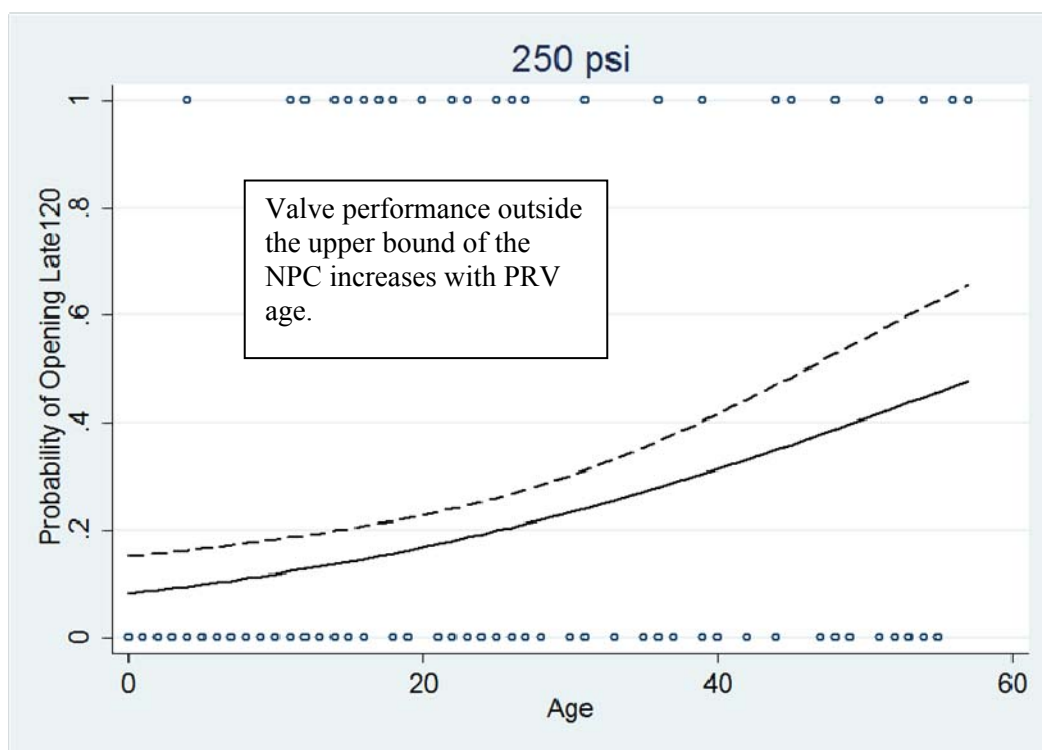
**Figure 3. Probability for 250-psi Set Pressure PRV to Open Late (>120 percent of set pressure) vs. Age (years)**

PRVs that discharged late (>120 percent of the set pressure) were considered to have performance outside the bounds of the NPC. As shown in Figure 3, the probability for a PRV to discharge above this limit accelerates for PRVs older than 25 to 30 years of age as indicated by the increased slope of the line. The probability for new PRVs to open 120 percent above the set pressure can range from approximately 8 to 15 percent (with 95-percent confidence) increasing to 31 to 42 percent (with 95-percent confidence) for 40 year old PRVs. Note that these percentages refer to the response of the PRV to the applied pressure.<sup>1</sup>

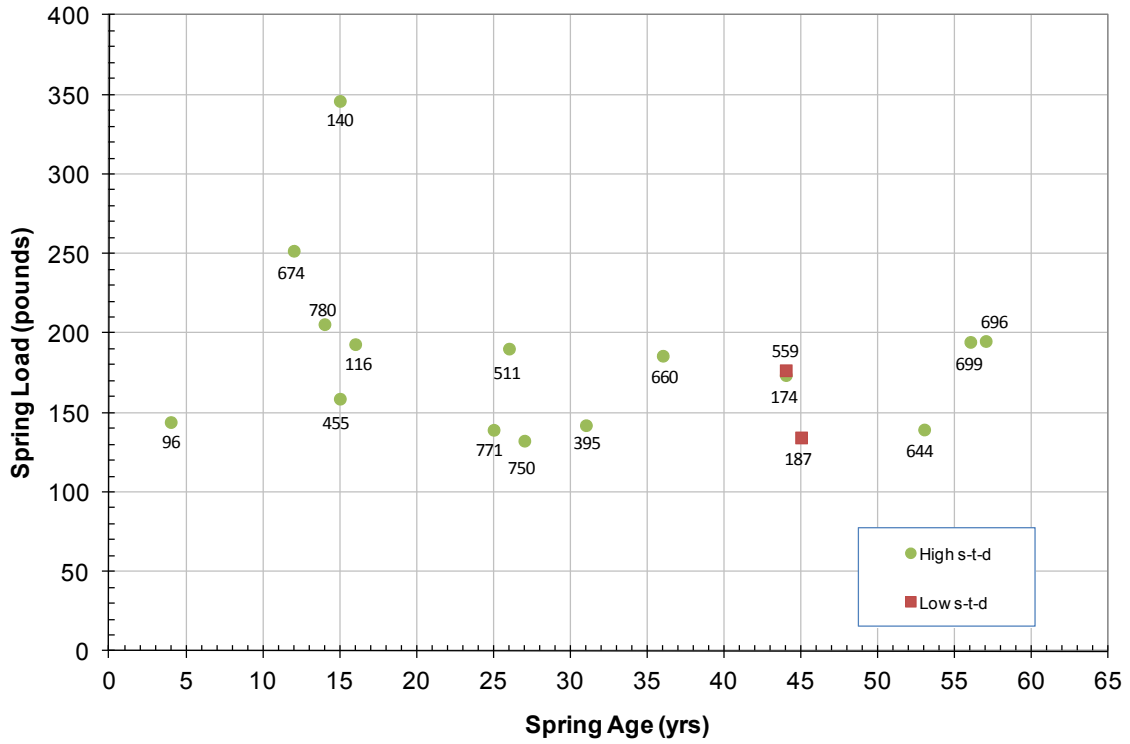
**Figure 4. PRV Spring Load vs. Age – 250-psi Set Pressure PRVs**

Figure 4 and Figure 5 do not indicate a loss in PRV spring load as a function of time in service. Thus the spring analyses from the various PRVs evaluated does not indicate that stress relaxation (load loss) contributed to the deterioration in PRV performance against the NPC.

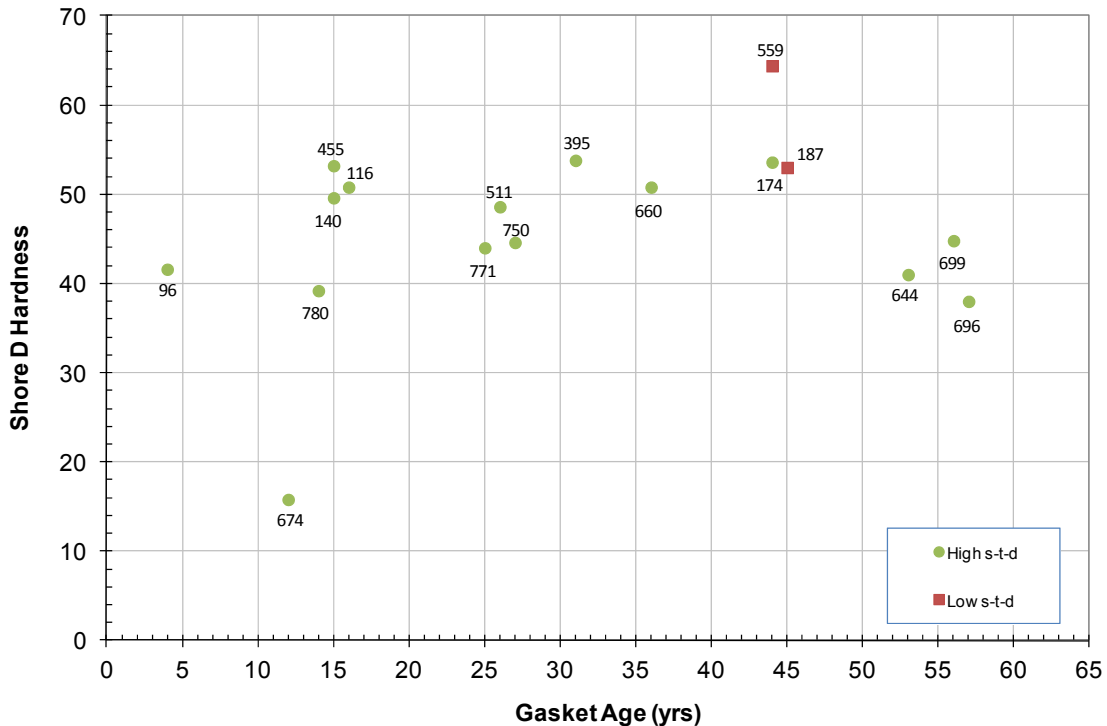
**Figure 6. Gasket Hardness versus Age – 250-psi Set Pressure PRVs**

The hardness of the gaskets ranged from 16 to 64 Shore D. However, the original hardness of the gaskets when produced was not known; thus estimates of how gasket hardness may have changed over time could not be made. The hardness of all the gaskets by performance issue (did not open, high STD, low STD) was plotted versus their age to see if there were general trends in their behavior over time (see Figure 6 and Figure 7). The data shows no strong trends or correlations.

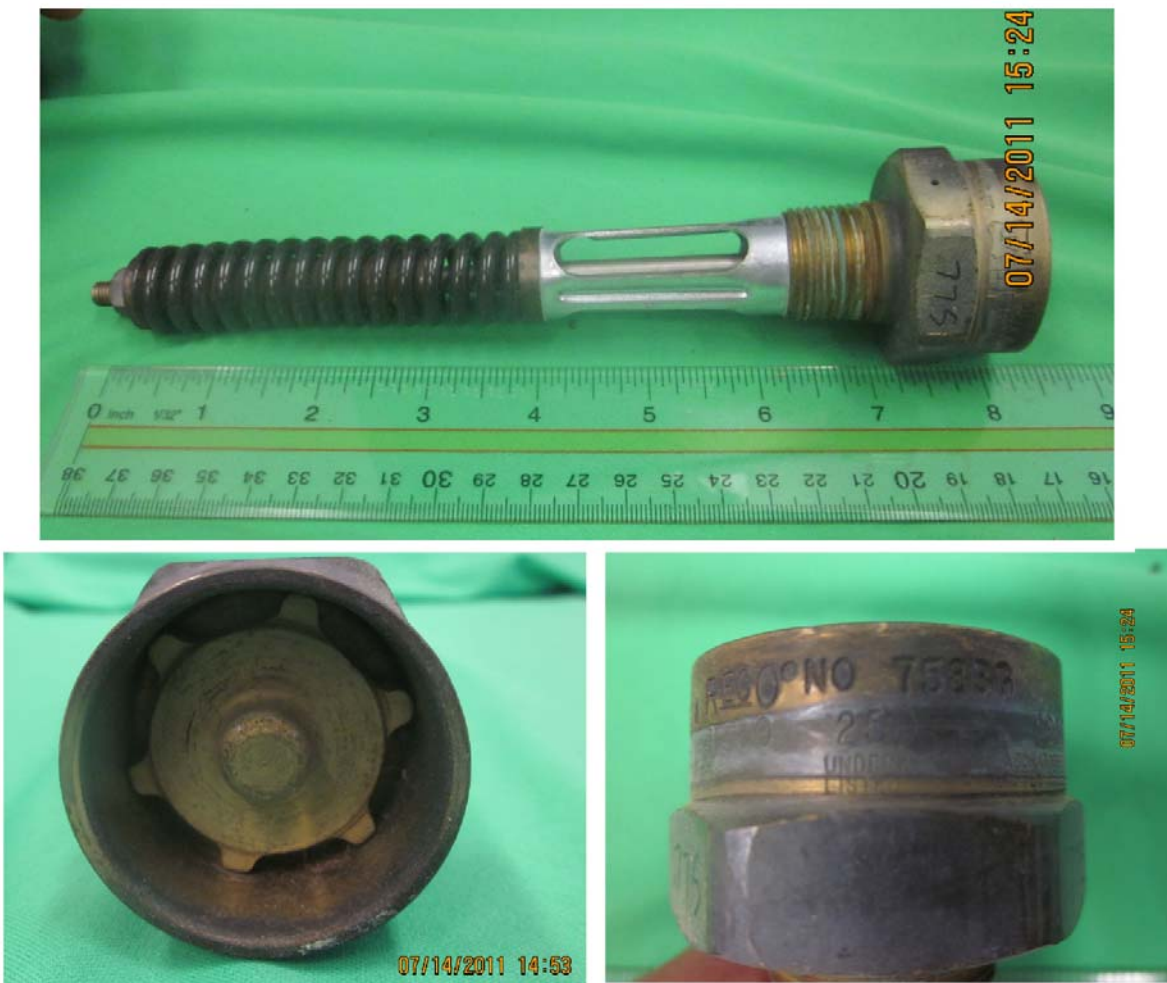
**Figure 10. Representative Photos Collected for Each PRV**

Photographs of each PRV were collected upon completion of the visual inspection. An example of the photographs collected is shown in Figure 10. Combined with the visual inspection, these efforts document the “as received” condition of each PRV. The documentation also creates a reference point for future enquiries about the received condition of the PRV for both the current and possible future considerations.

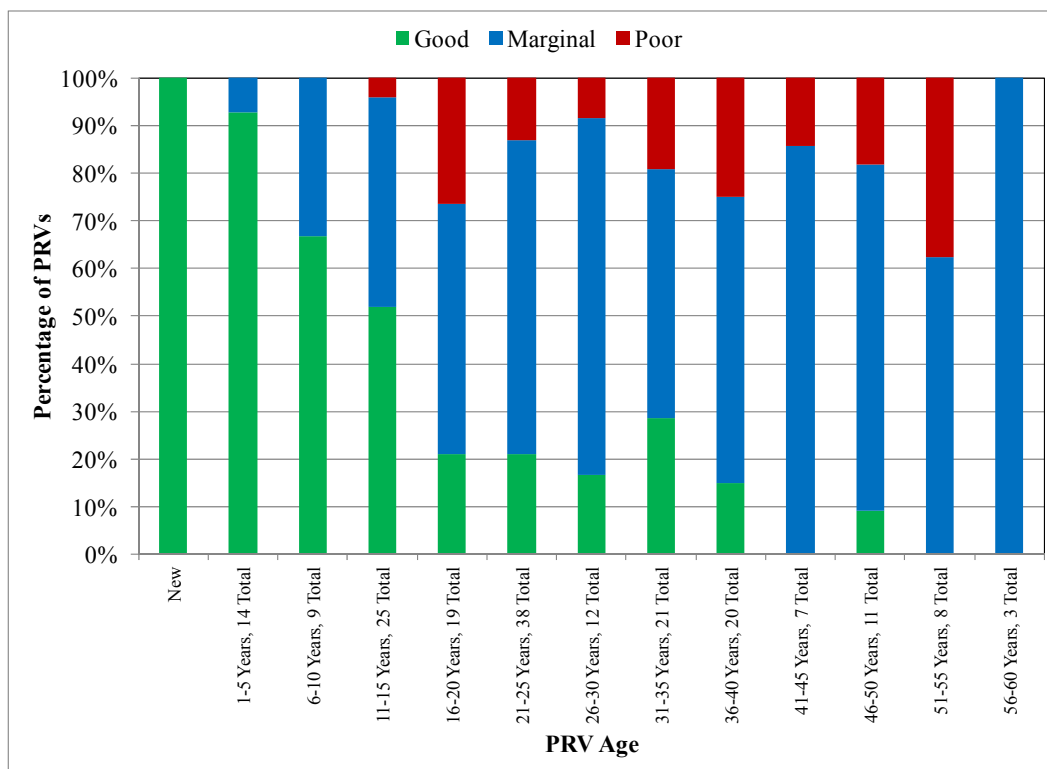
**Figure 12. PRV Visual Inspection Ratings by Age**

Figure 12 shows the expected degradation of PRV condition with age. All new PRVs were documented as ‘good’ condition for their visual inspection. The percentage of PRVs in ‘good’ condition slowly declines as the age of the PRV increases coincident with the rise of PRVs that received a ‘marginal’ rating for the visual inspection. The first ‘poor’ visual inspection ratings appear after 10 years of service. Note that these ratings are an indication of the PRV condition based on observations of care and maintenance; they are not measures of actual PRV performance.

The overall percentages of PRVs receiving good, marginal, and poor visual ratings did not have a strong correlation to connection size or set pressures, as shown in Figure 14 and Figure 15. Note that in Figure 15 while the percentage of ‘good’ ratings 275-psig set pressure PRVs is considerably lower than for 250-psig set pressure PRVs, this is likely due to the relative age of the PRV samples. Only three of 50 tested 275-psig PRVs had an age less than 20 years while 77 of the 150 tested 250-psig PRVs had an age less than 20 years. As shown in Figure 12, at ages in excess of 20 years the majority of PRVs receive a ‘marginal’ rating.

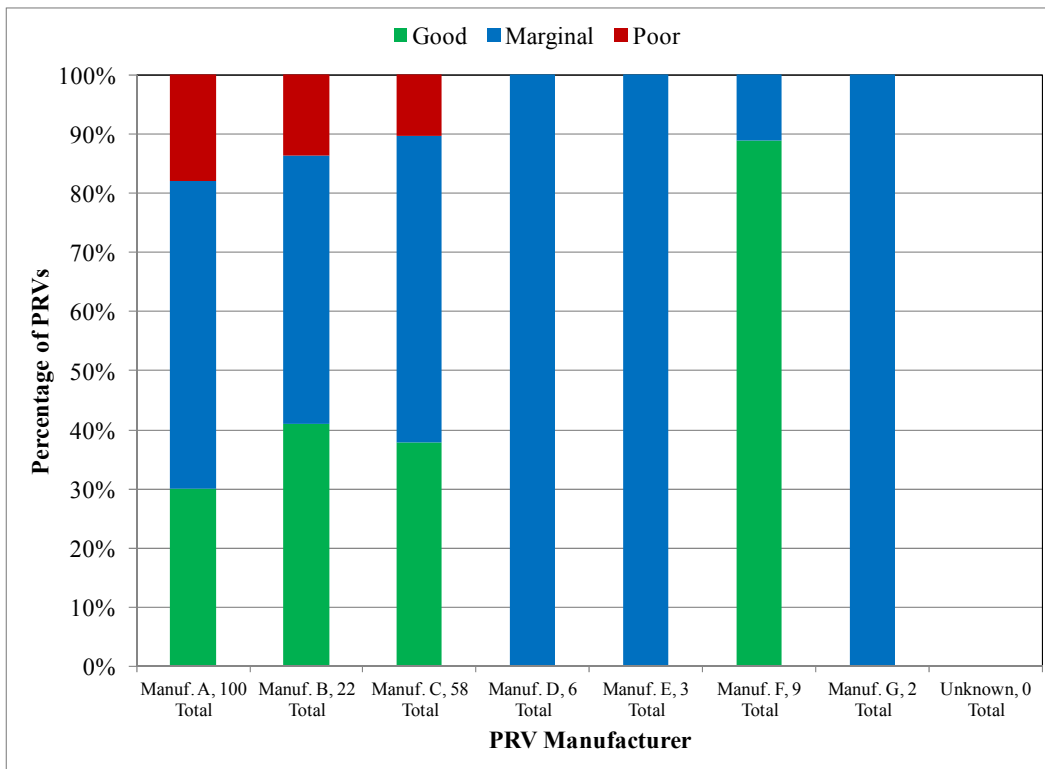
**Figure 13. PRV Inspection Ratings by Manufacturer**

Figure 13 shows the breakdown of PRV ratings by manufacturer. Manufacturers A, B, and C all had similar percentages of good, marginal, and poor ratings. The lack of good or poor ratings for Manufacturers D, E, F, and G are likely due to the relatively low number of PRVs in these categories (20 combined) rather than an inherently superior design, manufacturing process, or maintenance.

- Manufacturer C did have the lowest percentage of poor visual inspection results (Figure 13). Although the visual inspection ratings are subjective, the intent was to characterize the general condition and operability of the PRV.

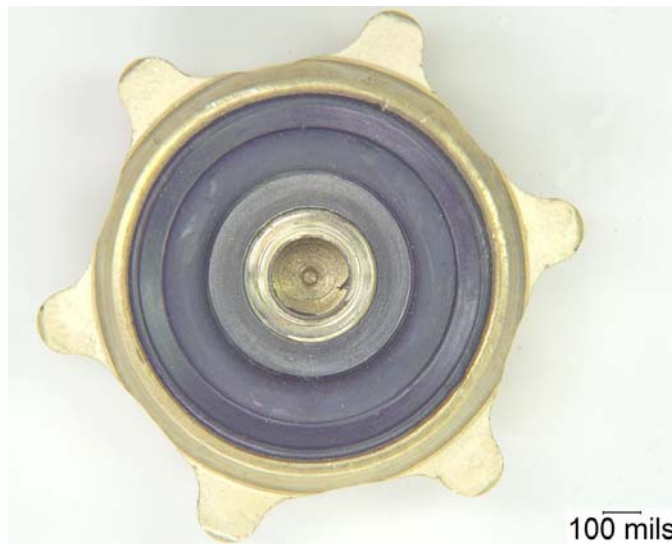
Examination of the gaskets from the PRVs visually and under a low-power stereomicroscope revealed that all of them exhibited compression set rings. Those rings would be expected since the relatively soft gaskets were essentially statically loaded under hundreds of pounds of load for their service lives. On nine of the 250-psig set pressure PRVs and four of the 275-psig set pressure PRVs, the compression set rings were concentric indicating that the gaskets were centered in the PRV housings. Figure 51 illustrates the concentric compression set rings in the surface of the gasket from PRV 96. For the remainder of the PRVs (eight 250-psig set pressure and three 275-psig set pressure), the compression set rings were not concentric, indicating that the gaskets were not centered in the PRV housings. That condition could indicate possible misalignment of the PRV stem in the PRV. Figure 52 and Figure 53 illustrate the nonconcentric compression set rings in the gaskets from PRVs 116 and 174, respectively. However, this characteristic did not appear to significantly influence the PRV performance during pressure testing.

**Figure 51. Concentric Compression Set Rings in the Gasket from PRV 96.**

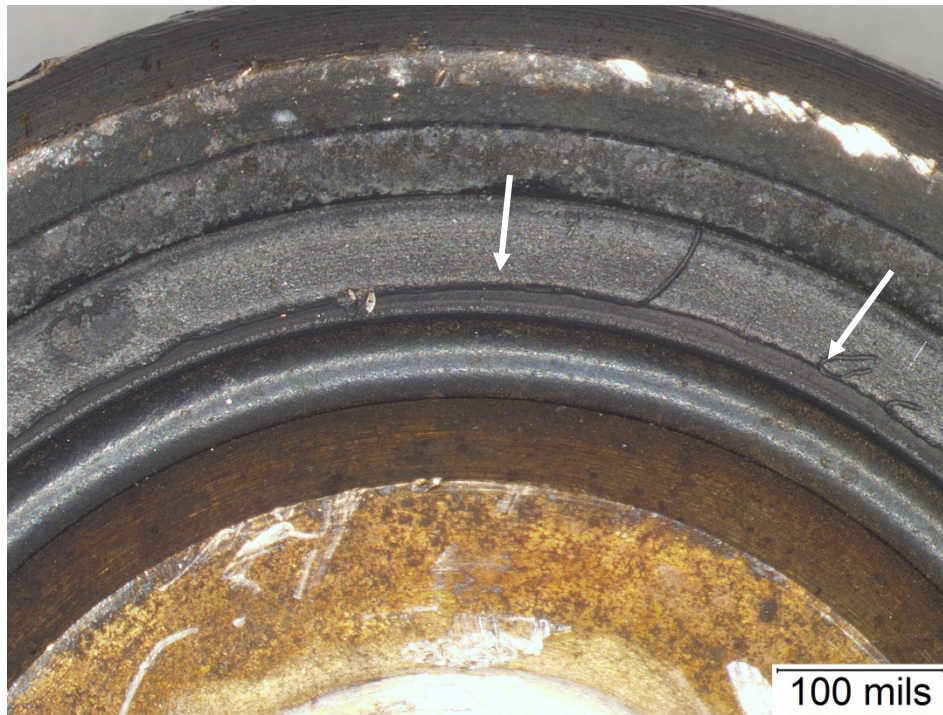
The gaskets from two of the PRVs, PRV 696 and PRV 699, exhibited evidence of material pull out and transfer of gasket material to the machined seal surface of the housing of the PRV. Figure 56 and Figure 57 shows the regions of material pull out from the seal surface of the gasket from PRV 696 at two different magnifications, respectively. Figure 58 shows the gasket material transferred onto the machined brass seal surface of the housing from PRV 696. It is possible that sticking of the gasket material may have contributed to the high STD pressure of the PRV.

**Figure 57. Higher Magnification view of a Region of Material Pullout (arrows) from the Seal Surface Region of PRV 696.**

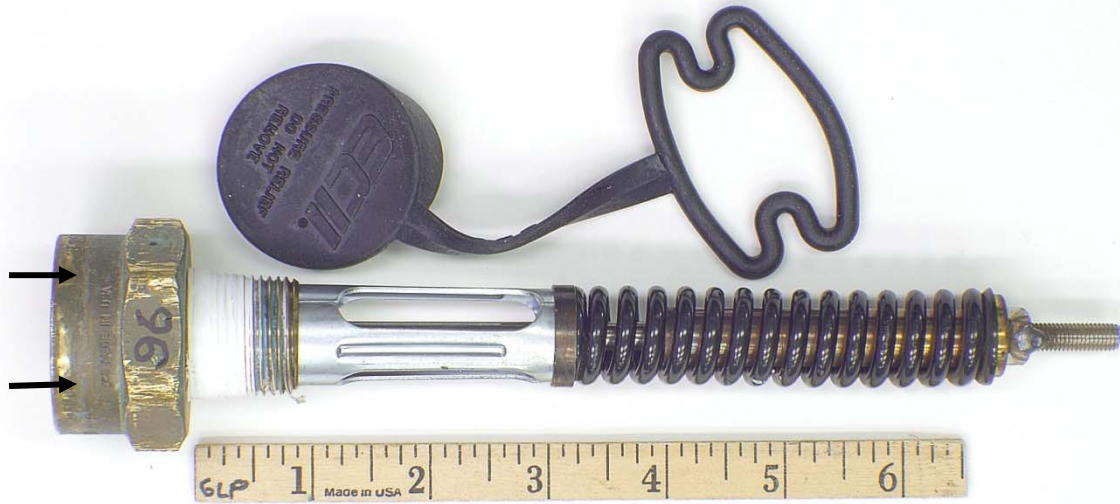
Figure 63 shows PRV 96 and the external rain cap that accompanied the PRV. The arrows on Figure 63 point to the faint rain-cap line on the external surface of the PRV housing. Figure 64 shows PRV 116 and the internal rain cap that accompanied the PRV.

**Figure 63. PRV 96 with External Rain Cap.**  
*Note the faint rain-cap line (arrows) on the surface of the housing.*

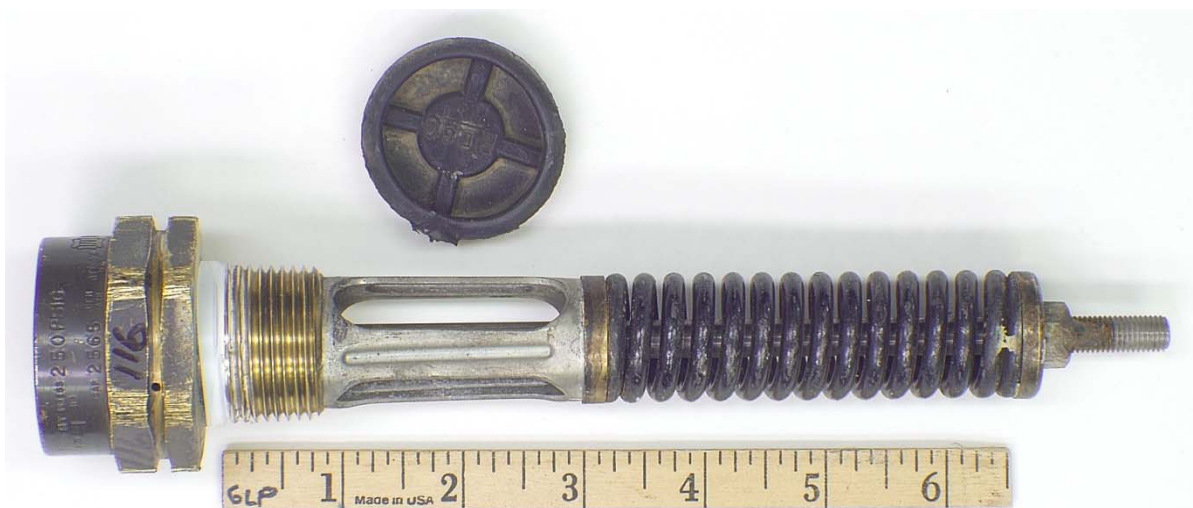
**Figure 64. PRV 116 with an Internal Rain Cap.**

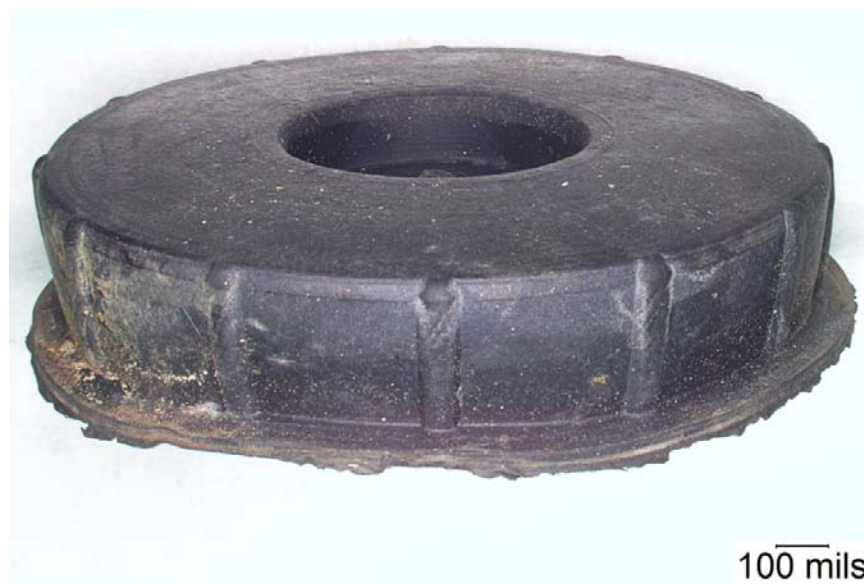
Figure 65 and Figure 66 show the ribs that were molded on the surface of the internal rain cap and the resulting marks and rain-cap line on the internal surface of the housing from PRV 116. PRVs 455 and 523, which were not accompanied by internal rain caps, showed similar markings on the inside surfaces of their housings (see Figure 67 and Figure 68).

**Figure 65. Ribs on the Surface of the Internal Rain Cap from PRV 116.**  
*According to experienced personnel, even rain caps that remain in place on the PRV can curl up and allow rain to enter the PRV housing.*

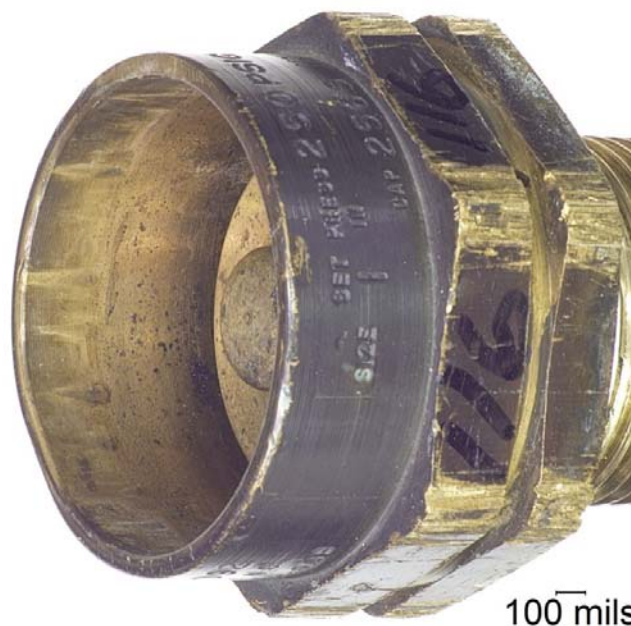
**Figure 66. Rain Cap Line and Marks from the Ribs on the Rain Cap on the Internal Surface of the Housing from PRV 116.**

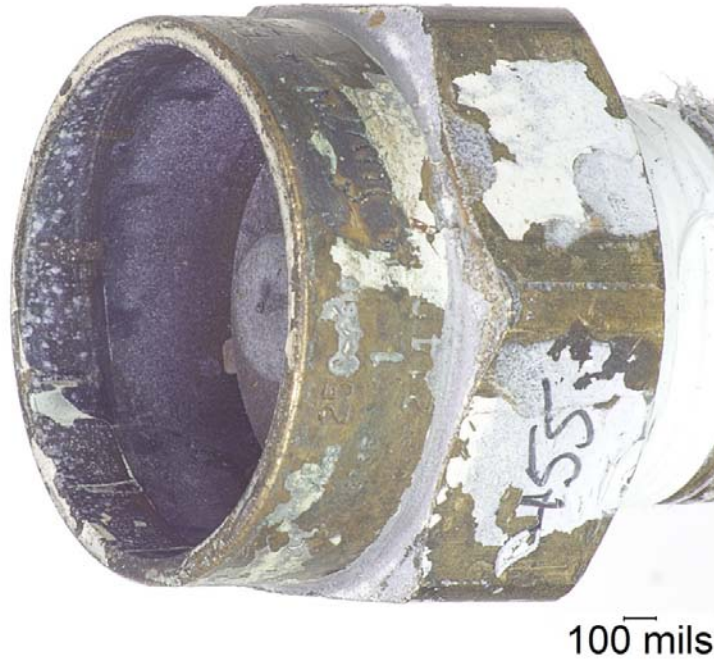
As is shown in Figure 67, the white paint splatches and discoloration of the housing surface from exposure to the atmosphere in the region where the rain cap had been indicate that the rain cap likely had been in place for only a portion of the service life of the PRV.

**Figure 67. Marks on the Inside Surface of the Housing from PRV 455 Indicating that an Internal Rain Cap had been Present for Only a Portion of the Service Life of the PRV.**

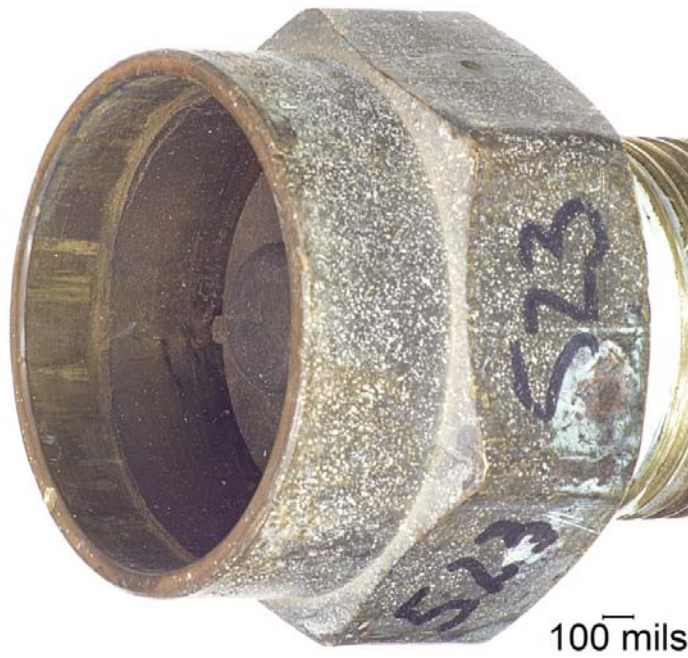
**Figure 68. Internal Marks and Rain-Cap Line on the Internal Surface of the Housing from PRV 523.**

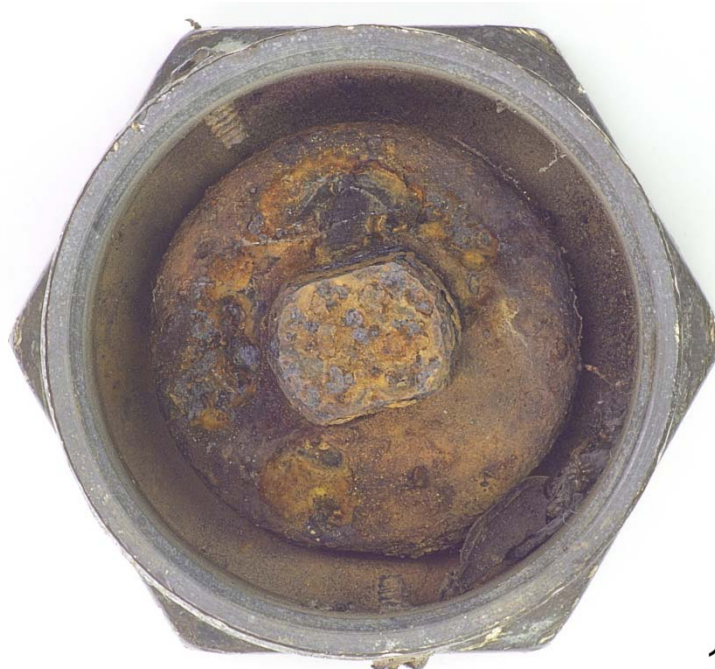
**Figure 77. Discoloration of the Internal Surface of the Housing, Debris Inside the Housing, and Rust on the Surface of the Gasket Holder from PRV 760.**

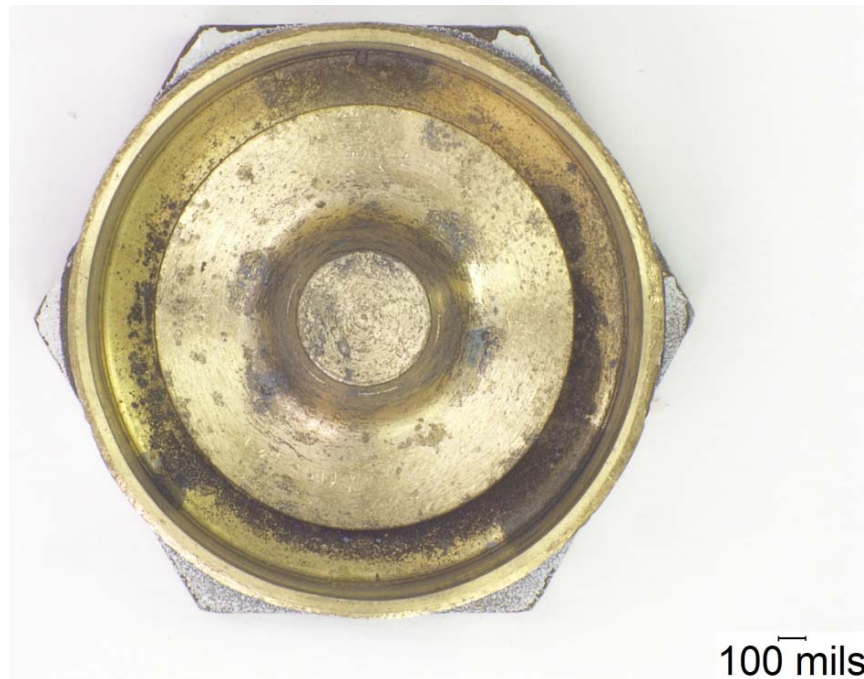
**Figure 85. Slight Discoloration of the Inside Surface of the Housing and the Gasket Holder from PRV 674.**

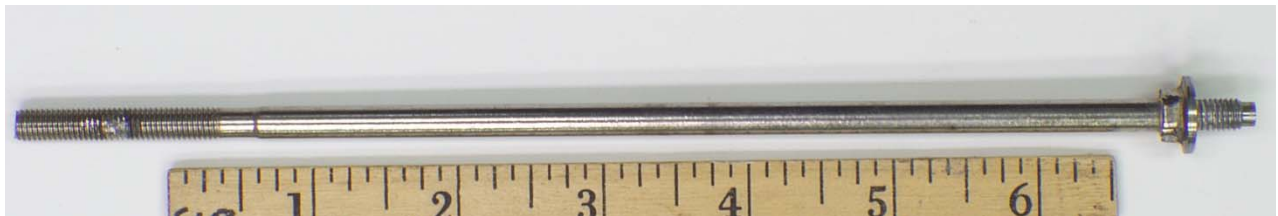
**Figure 91. PRV Stem for PRV 96.**

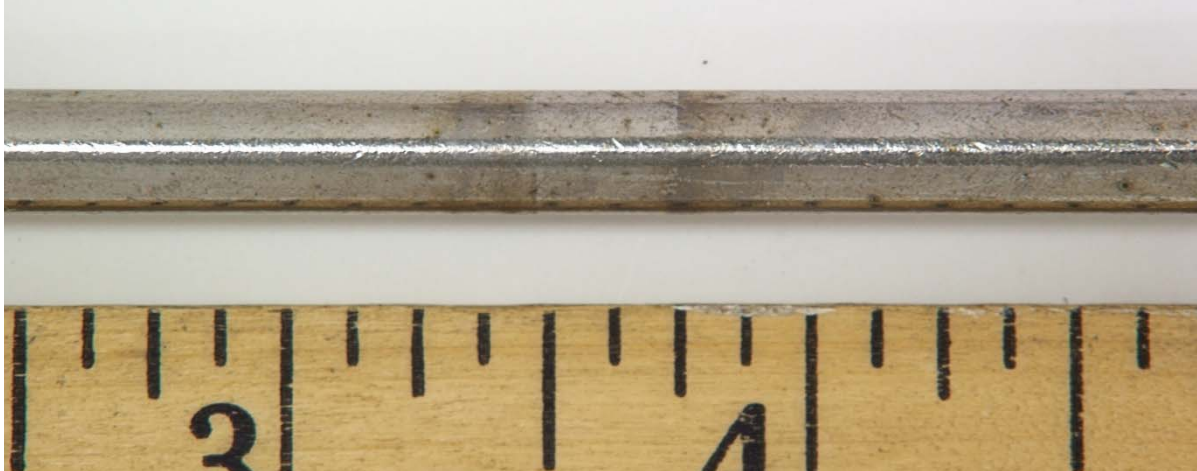
None of the other PRVs that exhibited high STD behavior during testing exhibited the extent of corrosion to their components as did PRV 674. However, all of them did exhibit a distinct mark on the PRV stem formed by contact between the PRV stem and the spacer guides. Figure 90

**Figure 92. Mark on the Stem Formed by Contact between the PRV Stem and the Guide Spacer/Washer from PRV 96.**

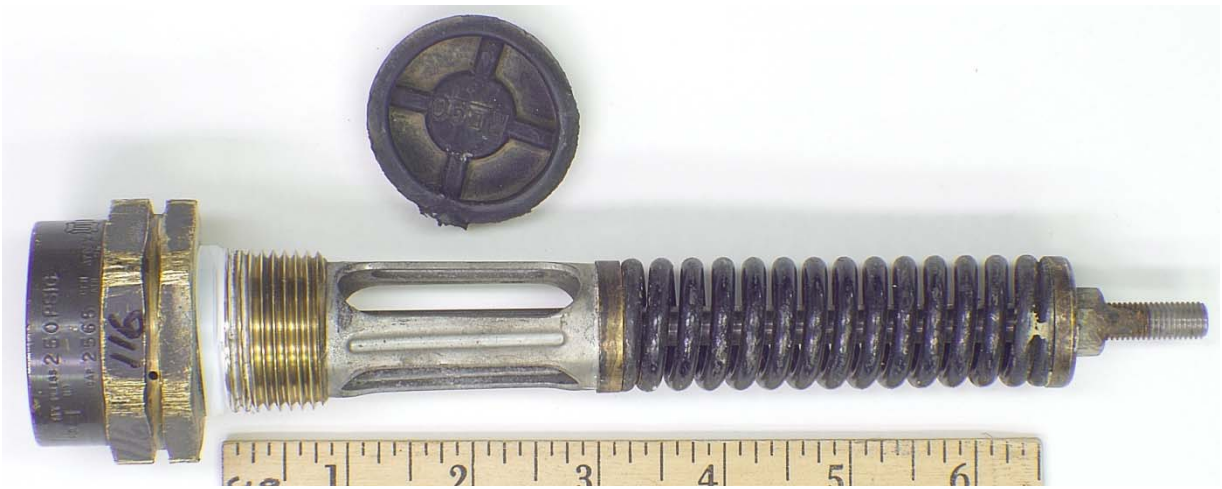
**Figure 93. PRV 116, 250-psig Set Pressure PRV that Exhibited High STD Behavior.**  
*This PRV was 16 years old.*

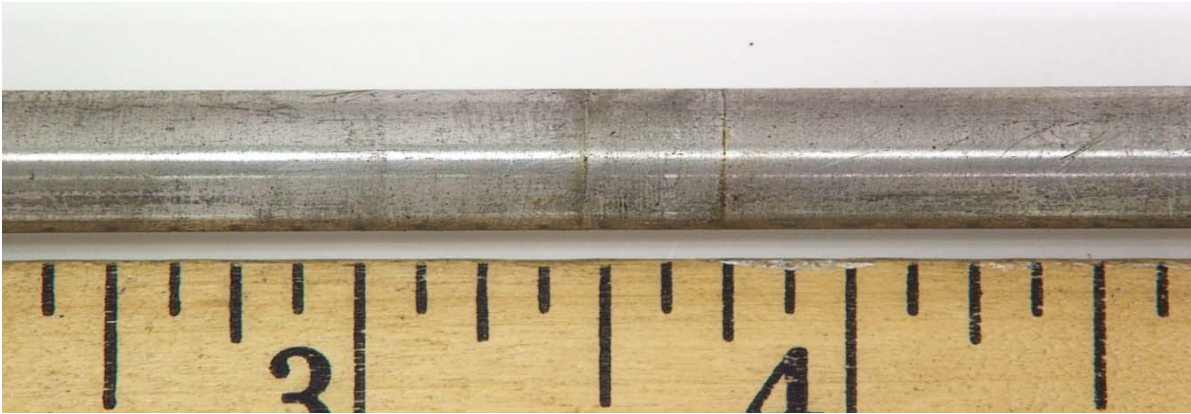
**Figure 95. Mark on the Stem Formed by Contact Between the PRV Stem and the Guide Washer from PRV 116.**

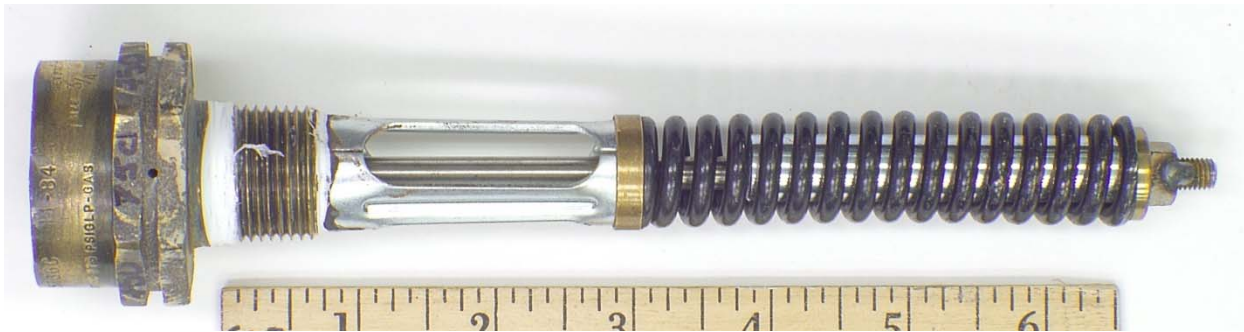
**Figure 96. PRV 750, 250-psig Set Point PRV that Exhibited High STD Behavior.**  
*This PRV was 27 years old.*

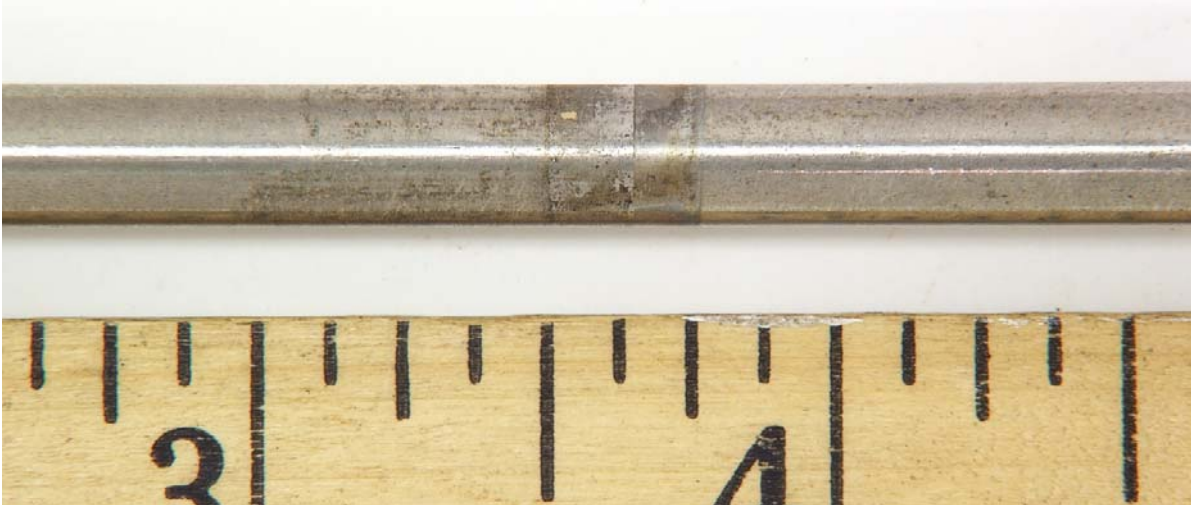
**Figure 98. Mark on the Surface Formed by Contact Between the PRV Stem and the Guide Washer from PRV 750.**

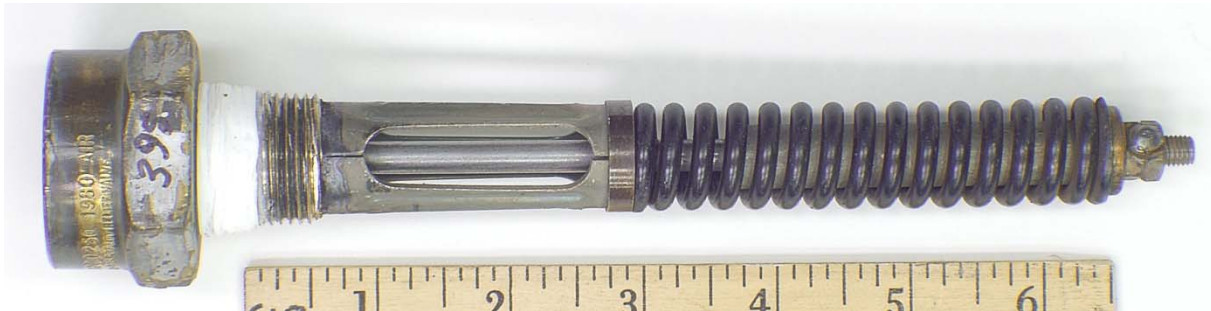
**Figure 99. PRV 395, 250-psig Set Pressure PRV that Exhibited High STD Behavior.**  
*This PRV was 31 years old.*

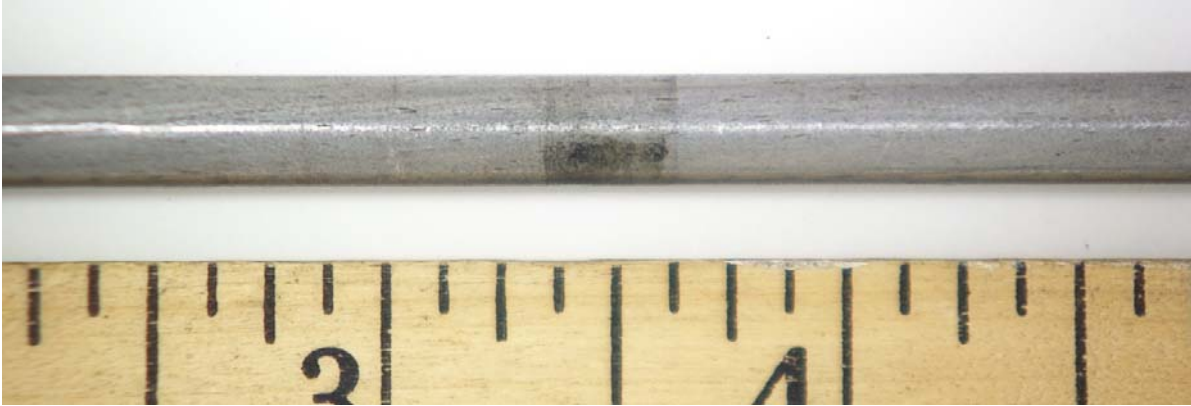
**Figure 101. Mark on the Surface Formed by Contact Between the PRV Stem and the Spacer/Guide from PRV 395.**

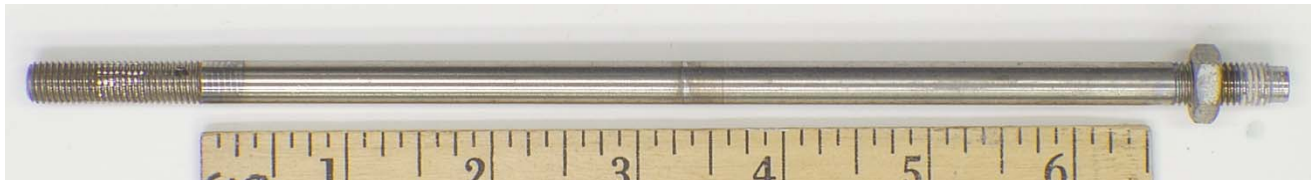
**Figure 102. PRV 523, 275-psig Set Pressure PRV that Exhibited High STD Behavior.**  
*This PRV was 31 years old.*

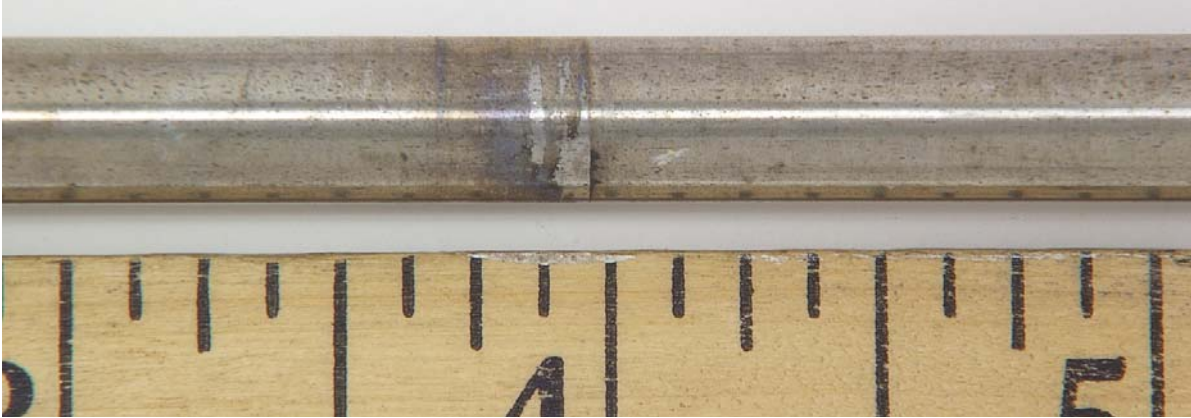
**Figure 103. PRV Stem from PRV 523.**

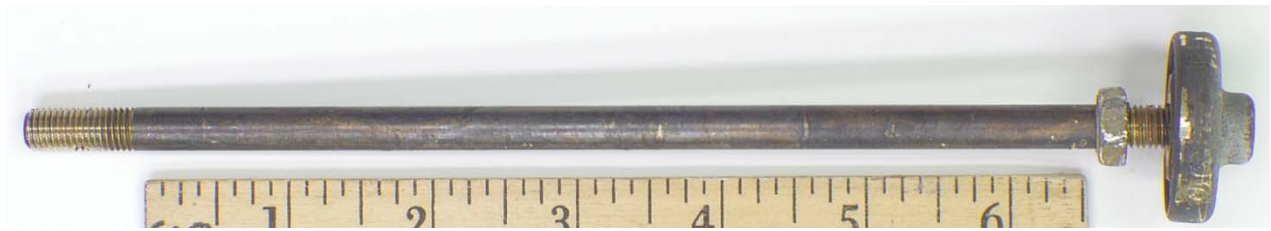
Figure 108 and Figure 109 show PRV 696 and its discolored PRV stem, respectively. This PRV was a 250-psig set pressure PRV that was 57 years old. When the PRV stem was checked with a magnet, it was found to be non-magnetic. Subsequent EDS analysis of a piece from that PRV stem revealed that it was fabricated from a leaded brass, most likely CDA Alloy C36000, free-cutting brass. The high STD behavior of this PRV may have been related to contact of the brass stem with the brass spacer guide and the oxidation that occurred between those contacting surfaces. Similar composition materials in intimate contact under static loads tend to bond over time.

**Figure 108. PRV 696, 250-psig Set Pressure PRV that Exhibited High STD Behavior. *This PRV was 57 years old.***

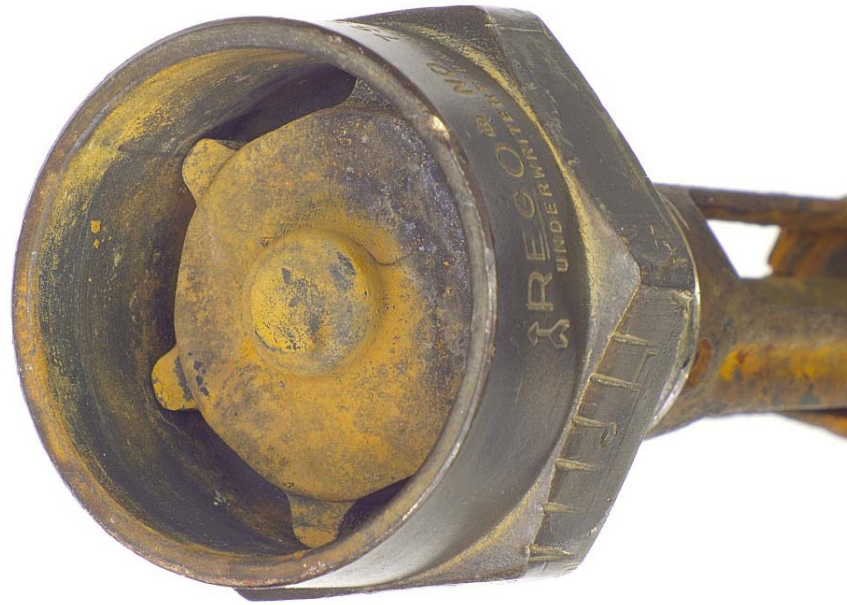
PRV 187 was extremely rusty when it was received at Battelle. Figure 110 shows the rust deposits on the surfaces of the PRV that were exposed to the propane environment inside the tank. The surfaces of the spacer (rolled steel) were corroded and the surfaces of the set pressure locking nut were corroded (attacked by a corrosive environment). Most of the rust on the surface of the PRV stem, the spring, and the spacer inside the spring appeared to have been deposited on those surfaces rather than formed by corrosion of the surfaces. Similarly, the rust on the internal surface of the housing and the surface of the gasket holder shown in Figure 111 were deposited on those surfaces because the components were brass and would not have formed red rust when corroded. It was as if this PRV was exposed to rusty water after removal from the tank.

**Figure 110. PRV 187.**

*Note the rust on the spacer, the spring, the lock nut, and the PRV stem. This PRV was 45 years old.*

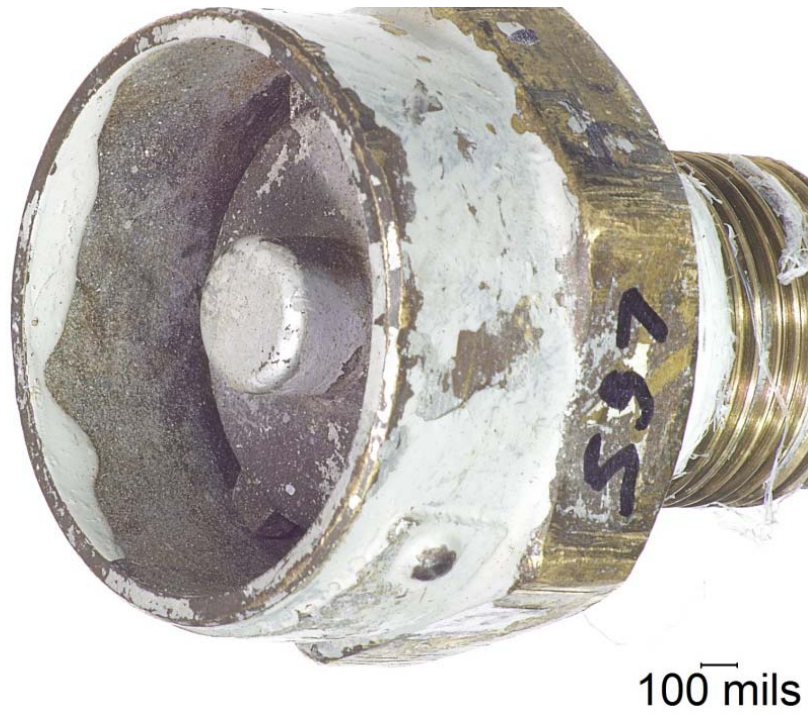
Figure 115 shows the appearance of PRV 597, a 275-psig set pressure PRV that exhibited low STD pressure behavior. This PRV was 40 years old but showed little evidence of corrosion during service (see Figure 116). The surfaces of the housing were discolored from exposure to the atmosphere and paint was present on the internal and external surfaces of the housing. Figure 117 and Figure 118 show the gasket from PRV 597. It appeared to be in relatively good condition; however, as shown in Figure 118 there was a replica of a dent in the machined surface of the housing in the surface of the gasket. The dent in the machined surface of the housing is shown in Figure 119. Those features in the gasket and the seal surface of the housing were the only deficiencies observed and they do not appear to be the reason for the low STD pressure behavior. As is shown in Figure 120 and Figure 121, the PRV stem from this PRV was somewhat corroded/discolored but it did not show a significant mark from contact with the brass spacer guide. Based upon this examination there is no conclusive evidence for the low STD pressure behavior.

**Figure 115. PRV 597, 275-psig Set Pressure PRV that Exhibited Low STD Behavior.**  
*This PRV was 40 years old.*

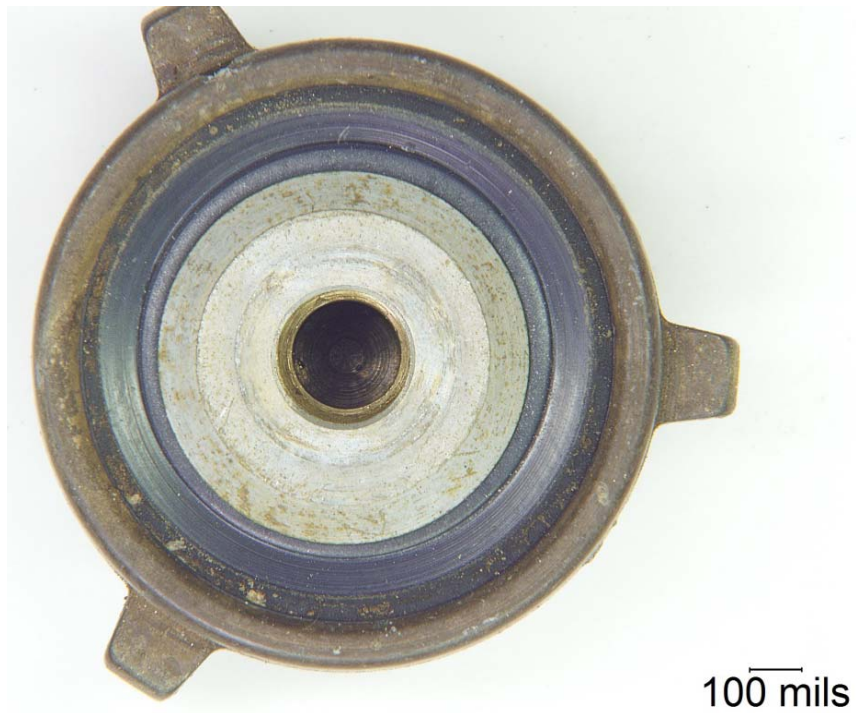
**Figure 116. Discoloration and Paint on the Internal and External Surfaces of the Housing from PRV 597.**

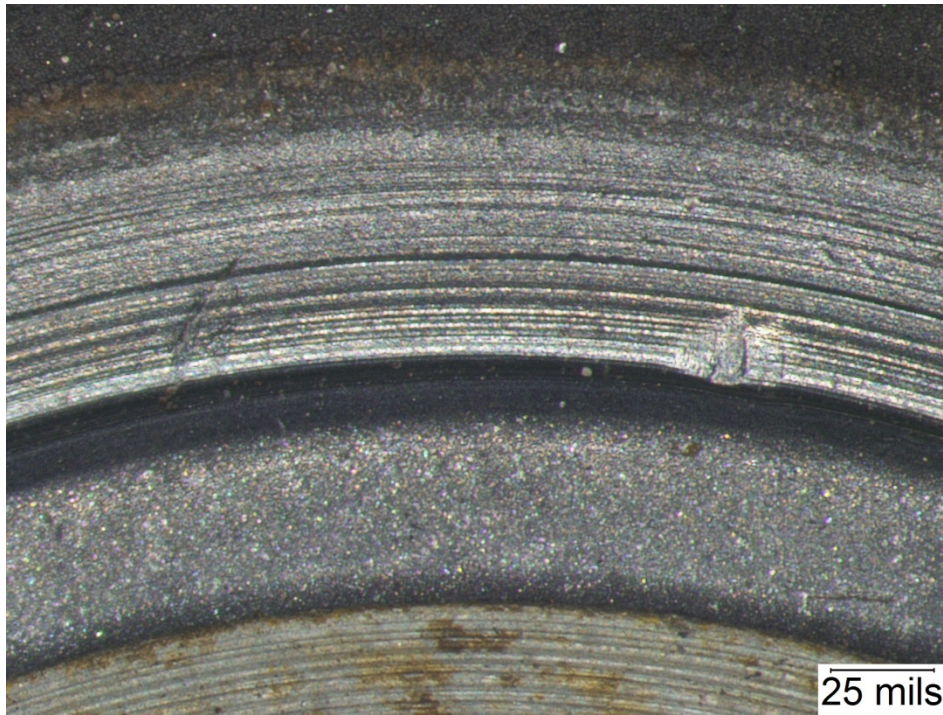
**Figure 117. Gasket from PRV 597.**

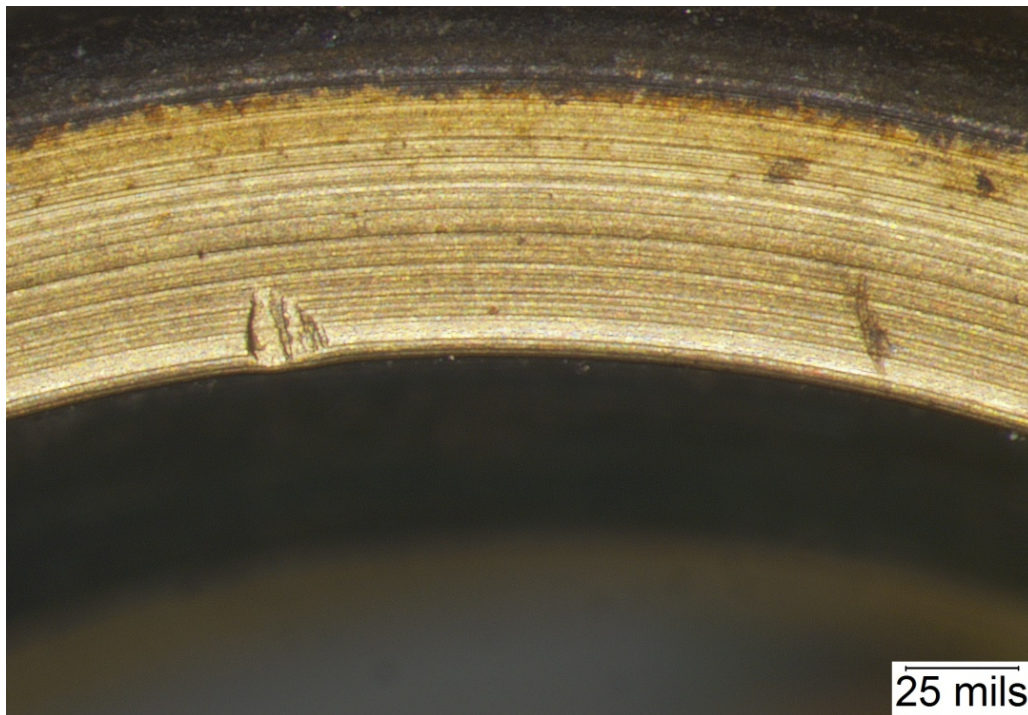
**Figure 118. Replica of a Dent in the Machined Sealing Surface of the Housing on the Surface of the Sealing Region of the Gasket from PRV 597.**
