# Testing and Analysis of the Performance of Pressure Relief Valves – New Test Protocol

## Volume I – Final Report

Battelle Project 100001707  
PERC Docket 17071

December 2011

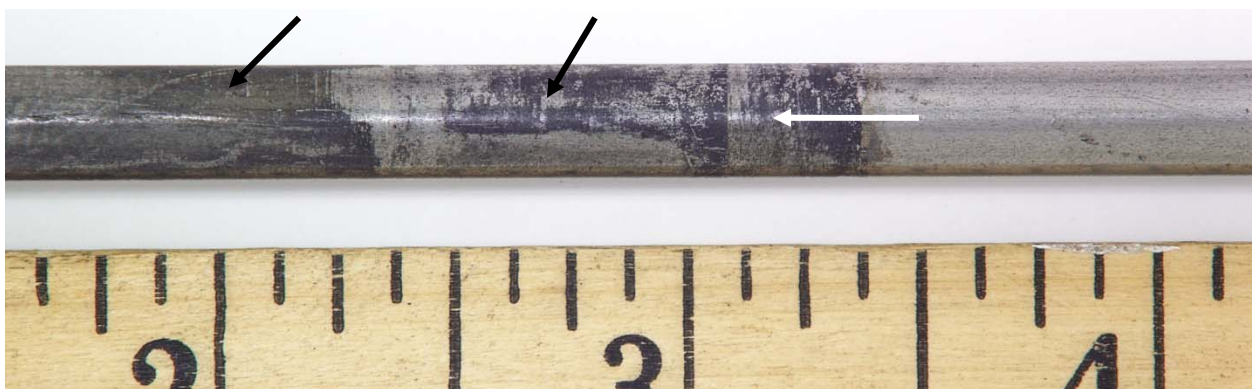
Figure 125 and Figure 126 show the contact marks and discoloration on the surface of the PRV stem. These marks did not contribute to the low STD pressure of the PRV.

**Figure 125. PRV Stem from PRV 733.**
